Preliminary Site Information Questionnaire (PSIQ)

1. **Historical Name of Property:** Fort Dodge
2. **Current Name or Other Names of the Property:** Fort Dodge: Kansas Soldiers' Home
3. **Street Address or Location (or Section/Township/Range):** Fort Dodge is located approximately 5 miles east of Dodge City, Kansas, on Highway 400 at 714 Sheridan, Fort Dodge, Kansas 67843
4. **City (or Vicinity):** Dodge City, Kansas **County:** Ford
5. **Historical Use:** Fort Dodge was a United States Army Post that protected those traveling the Santa Fe Trail and provided supplies and a resting place for traders and bison hunters. **Present Use:** The Kansas Soldiers Home is a State-operated facility on the grounds of Old Fort Dodge, an active military post from 1865-1882. The Fort was deeded to the State of Kansas in 1889 for conversion into a Soldiers' Home.

Site One: Fort Dodge Junior Officers Quarters (Condition Assessment)	Page 4 - 10
Site Two: Fort Dodge – Officers House (Condition Assessment)	Page 11 - 15
Site Three: Fort Dodge – Army Quartermaster Building (Condition Assessment)	Page 16 - 22
Site Four: Fort Dodge – Enlisted Men’s Barracks (Condition Assessment)	Page 23 - 29
Site Five:

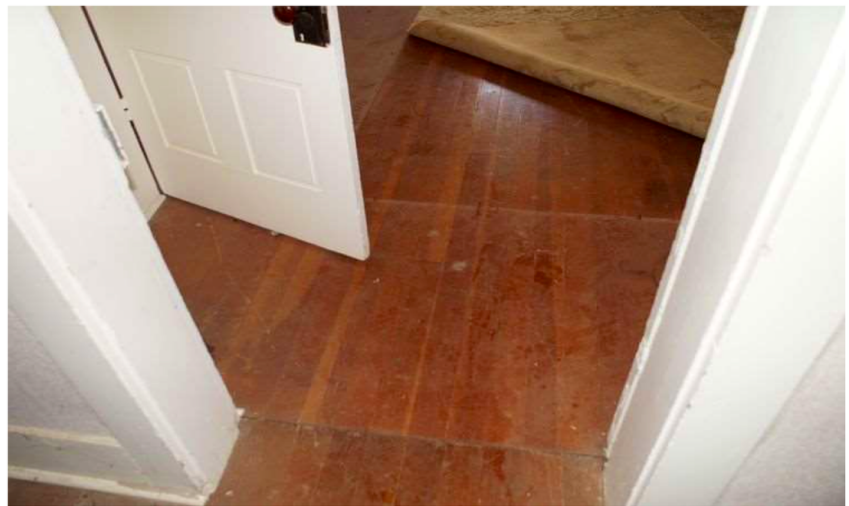
S1-006:Fort Dodge – Junior Officers Quarters. 226 Custer Street. Interior, second-floor west side of Junior Officers Quarters; view of hardwood floor's current condition. 08/16/2017. KSHS/Anderson, Rick.

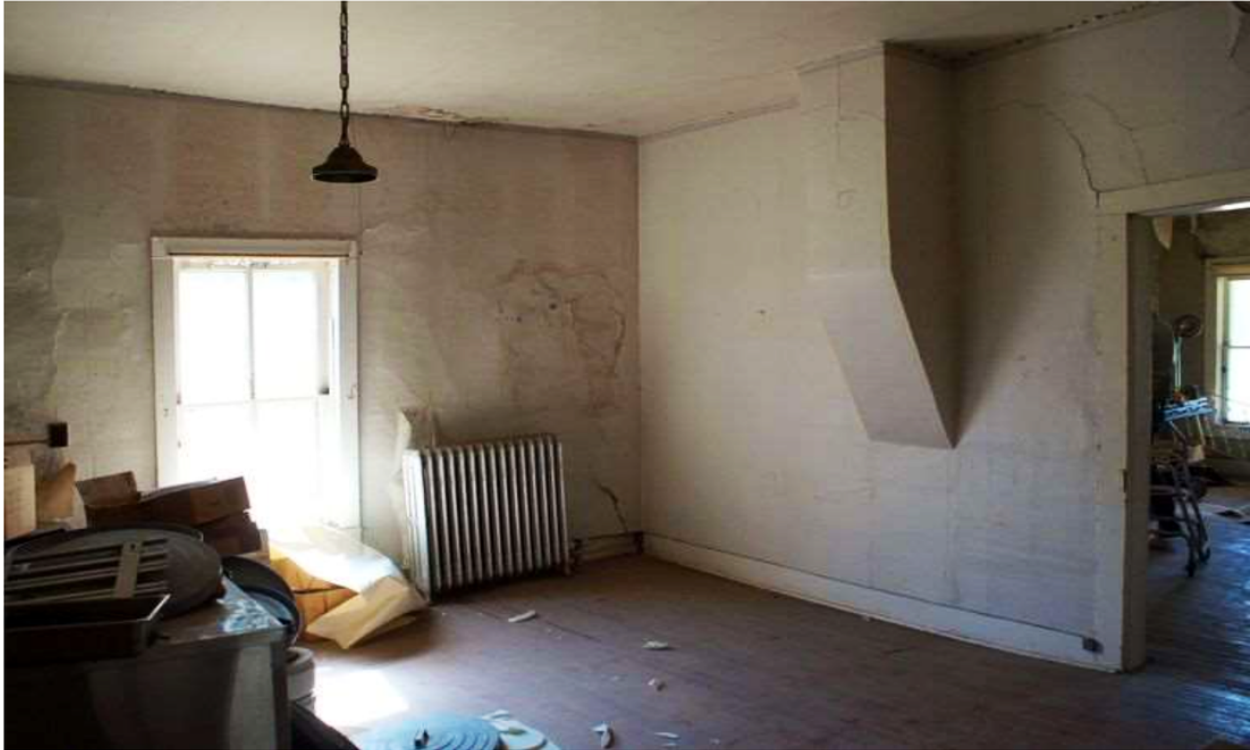
East; downstairs: northeast room has plaster cracking and loosening from the lathe on both sides of the window; most likely due to water intrusion. **Note:** this area matches the exterior where the siding is bowing near the windows. The ceiling in this same interior area shows the same concern from water above the window in this case. The plaster over the doorway between the east rooms is cracking in the same manner on both sides of the doorway. This may indicate a shift in the interior wall or floor. The floor in the northeast corner of the east room has settled/dropped down next to the exterior wall in the same area as the wall’s water intrusion.

S1-007: Fort Dodge Junior Officers' Quarters ca. 1870 (KHRI: 057-1426). Interior, first-floor east half of Junior Officers Quarters; looking southeast in the northeast room. The wall with the window is the area of water intrusion. Note plaster above register and to the right of the window.

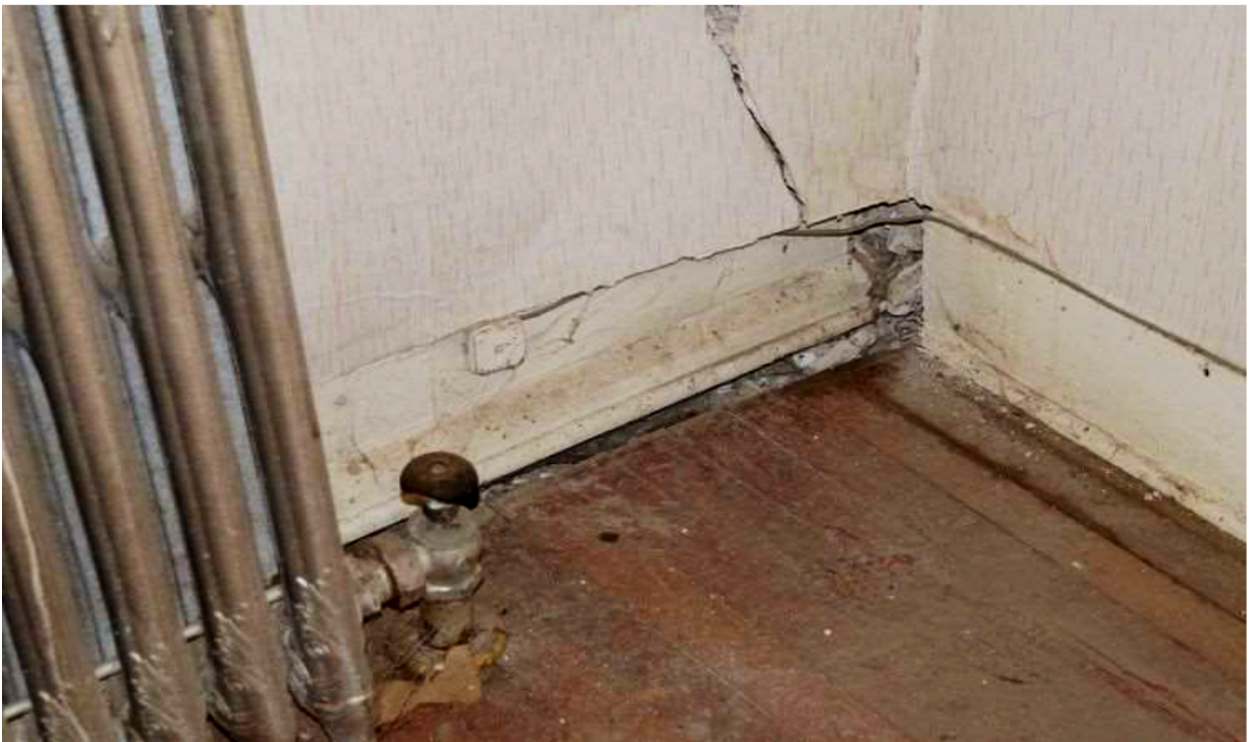
Interior structural cracks: Floor in the northeast corner of the northeast room is settling lower than the wall. (See “Other Evaluation” notes below.)

S1-008: Fort Dodge Junior Officers' Quarters ca. 1870 (KHRI: 057-1426). First-floor, east side of Junior Officers Quarters; water damage and settling of the floor from the wall in the northeast corner of the northeast room.

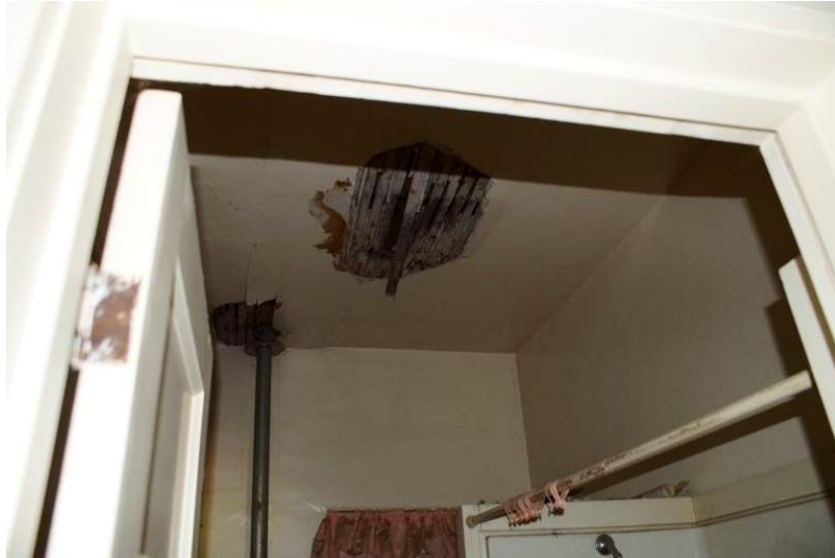
West; downstairs: water has leaked through the plaster and lathe towards the back corner of the exterior wall (See photo S1 - #009) and from the ceiling of the bathroom, also near an exterior wall.

S1-009: View of plaster/lathe in ceiling

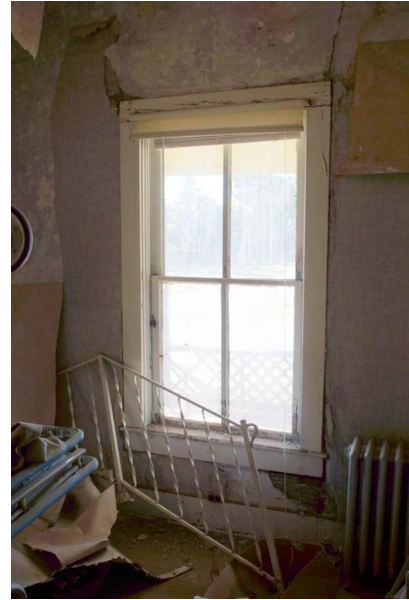
East, downstairs: southeast room: the inside wall is exhibiting the same concern as the outside wall as did the northeast room from probable water intrusion. (See photo S1 - # 010 for a view of the cracked plaster around the window area.)

S1-010 Water entry damaging plaster & floor

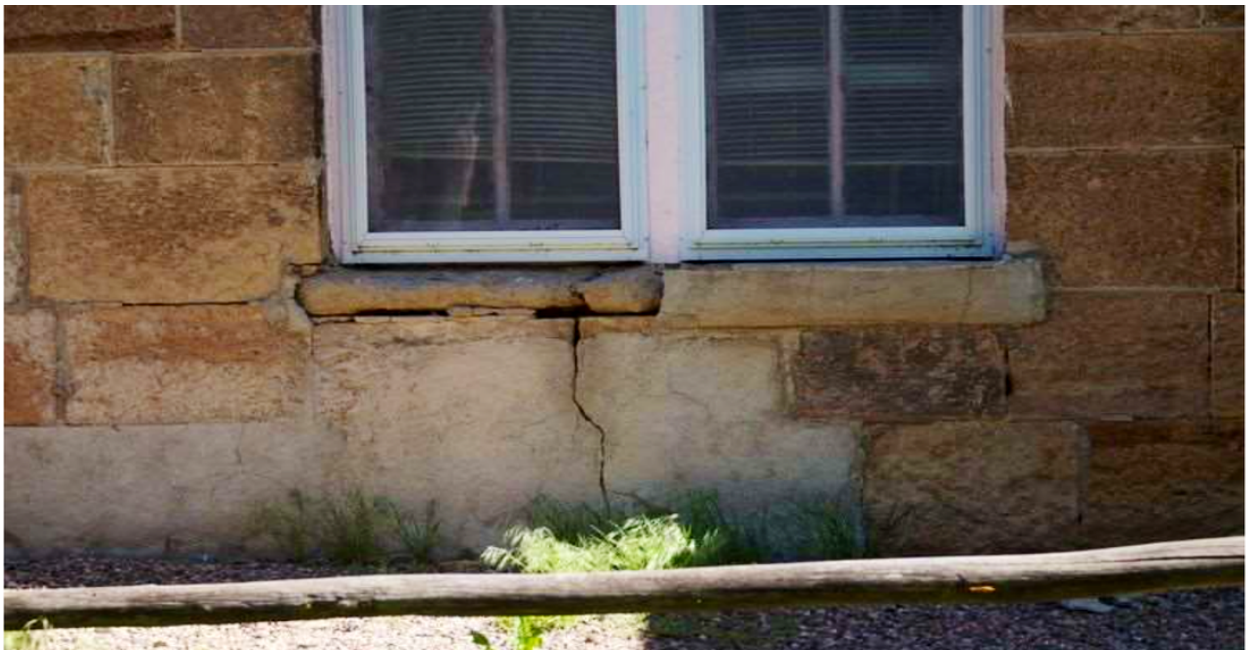
South elevation: has a crack extending upwards from the foundation through the window sill to the window. The window sill is broken in half. Concrete has been poured to replace the damaged wall stones below the window. A similar condition has occurred to the lower stones towards the front, southwest corner of the building on this elevation.

S2-002: Fort Dodge – Officers House. 702 Sheridan Street. South elevation windows; looking north. 05/25/2017. KSHS/Anderson, Rick.

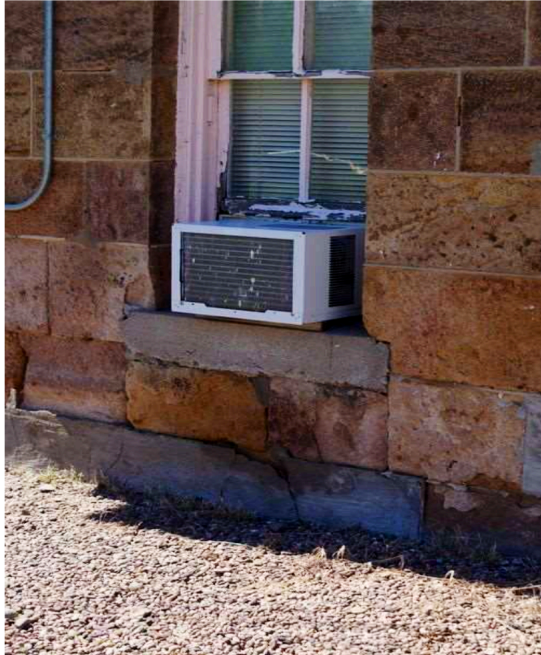
North elevation: similar deterioration as the south and east elevations. The original limestone window sill has been replaced with a concrete sill.

S2-003: Fort Dodge – Officers House. 702 Sheridan Street. North elevation window and a replaced, concrete window sill; looking southeast. 05/25/2017. KSHS/Anderson, Rick.

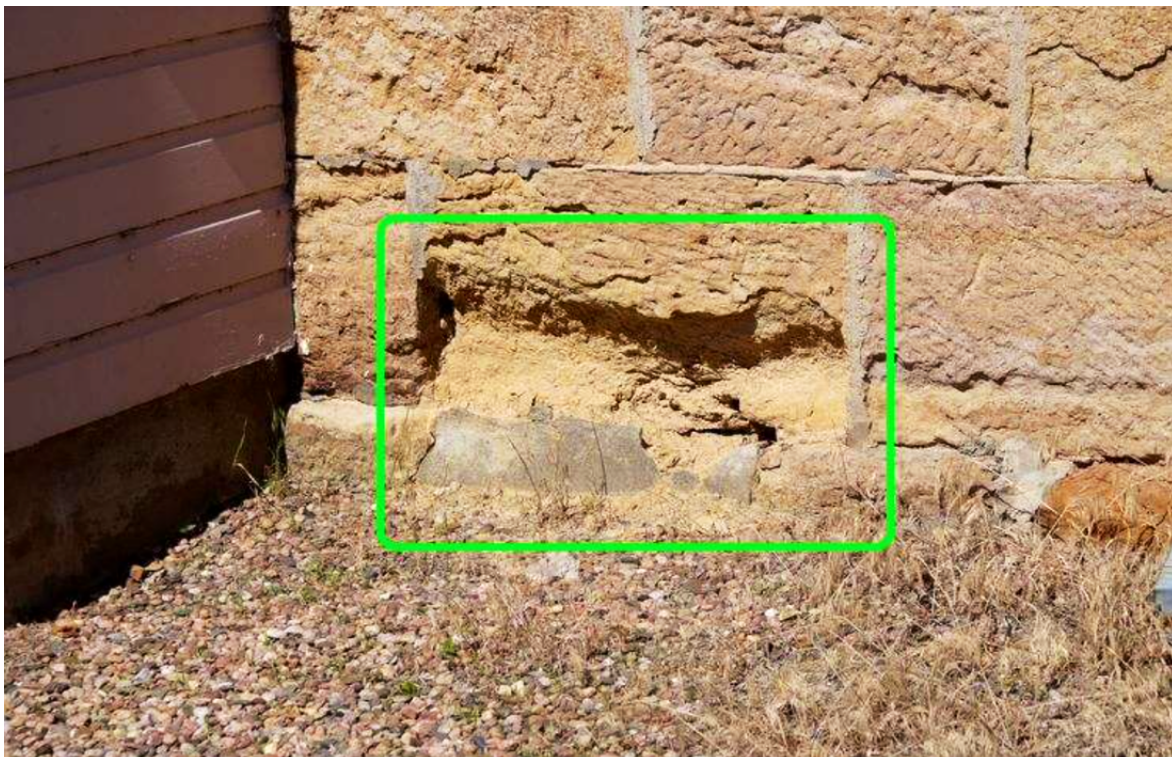
East elevation: same deterioration of the wall stones and sill below the window at ground level up to the window. The face of a stone has completely spalled off at the foundation level south of the damaged window sill and stones. This has also occurred towards the northeast corner of the building. This damage is above the concrete applied to the foundation.

S2-004: Fort Dodge – Officers House. 702 Sheridan Street. East elevation at ground level; looking west. 05/25/2017. KSHS/Anderson, Rick.

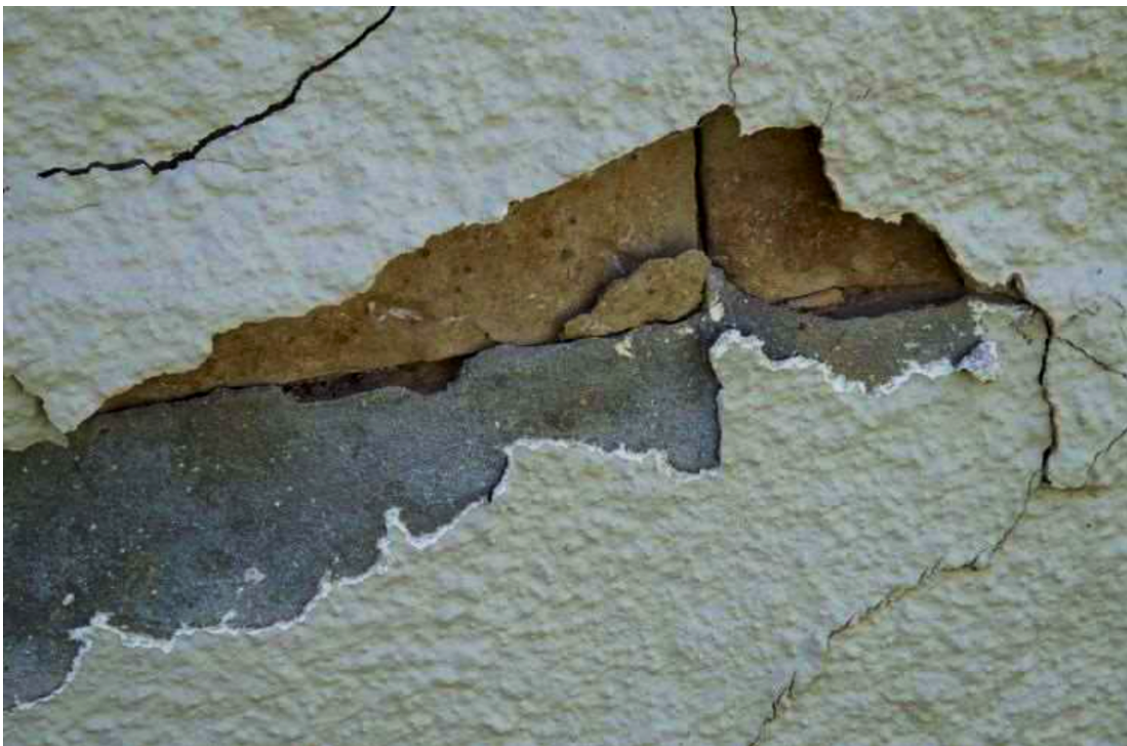
S3-002: Fort Dodge Army Quartermaster Building ca. 1867 (KHRI: 057-1399). West elevation; looking east. Note the application of concrete first under the second attempt with stucco.

Other damage notes: To summarize the damage would be best to address the application of stucco to the whole of the building. The stucco covering is separating and falling off in large patches on the west, south, and east elevations. The west and south elevations have sustained the most damage from the stucco. The faces of the limestone blocks on the affected elevations have suffered considerable spalling from the stucco removing itself. The lower level of the west elevation has an application of concrete (similar to the Enlisted Men’s Barracks building; KHRI 057-1821-00003) that is visible where the stucco has flaked off. Closer inspection of the damage shows the same concern in that the limestone blocks are spalling and cracking just above the concrete application.

Intervention level: Noted items should be kept under close observation. Develop a plan to slow down or eliminate further deterioration of the exterior.

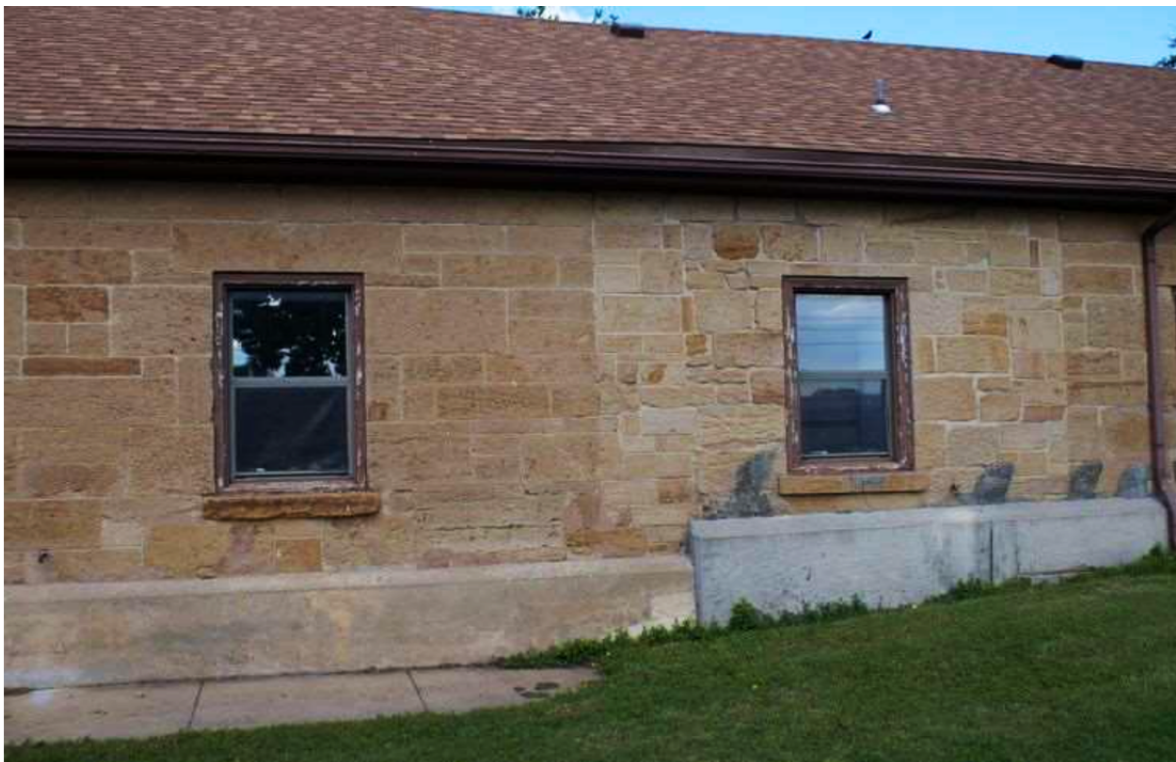
Foundation damage: Severe; concrete has been inappropriately poured on at least two different occasions coming in direct contact with the foundation and the lower wall surfaces of all elevations. See “Other notes” below.

S4-004: Fort Dodge Enlisted Men's Barracks ca. 1867 (KHRI: 057-1821-00003). East elevation of south barracks; looking west. Note two different applications of concrete/gunite to lower areas of the walls.

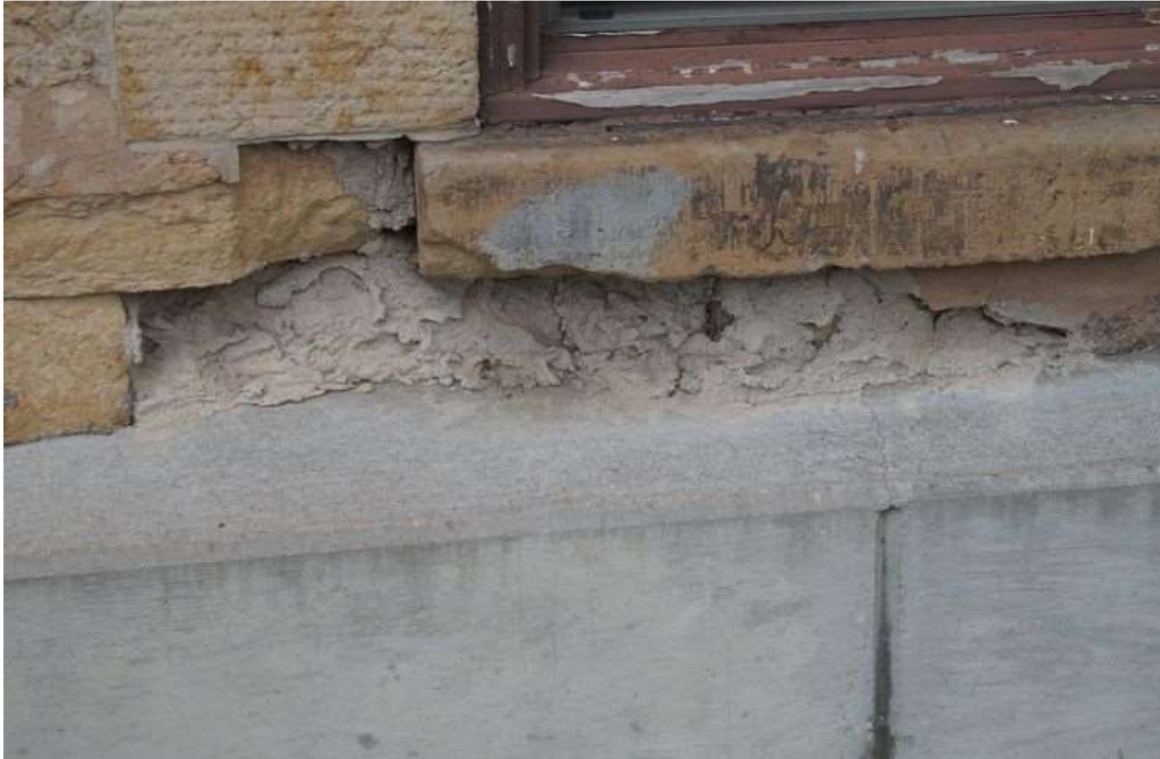
Exterior wall damage: Keystones have settled down out of position approximately 1/2” to 3/4” and the arches above the three front (east) entrances have wide mortar gaps and some limestone blocks are cracked through. Several of the window sills on the east elevation have spalled; possibly aggravated by moisture intrusion from the concrete on the walls underneath. See “Other notes” below.

S4-005: Fort Dodge Enlisted Men's Barracks ca. 1867 (KHRI: 057-1821-00003). South barracks east elevation, typical window sill and spalled sandstone just above the concrete/gunite; looking west.

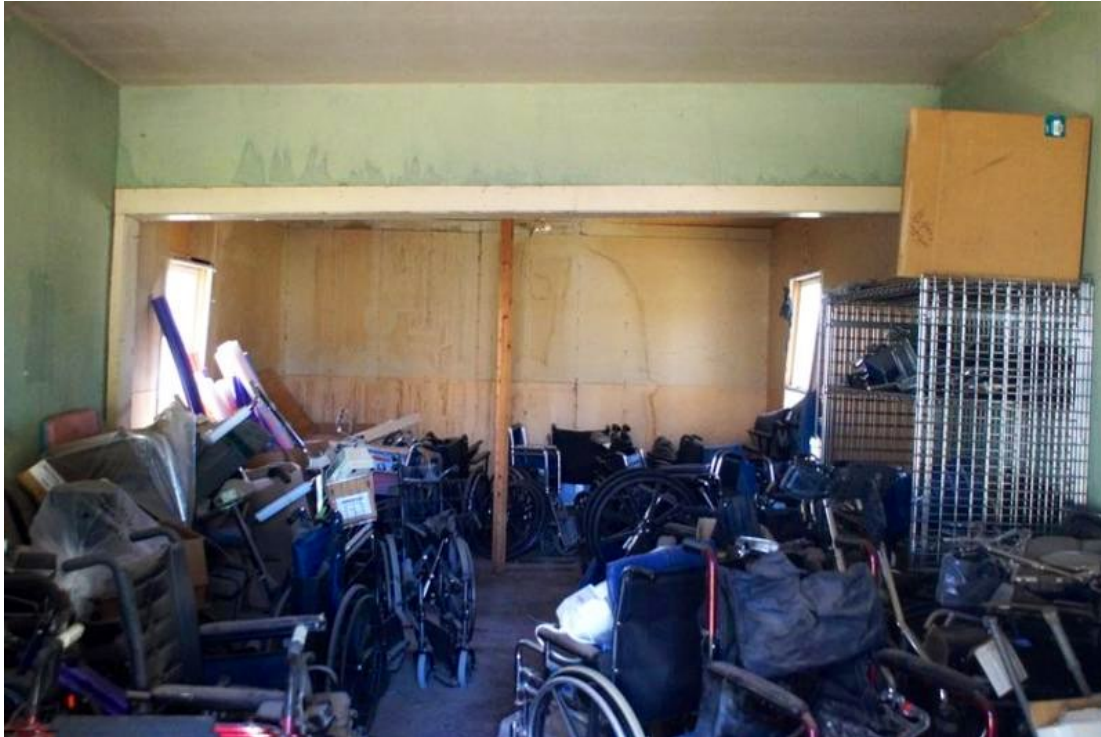
S5-006: Fort Dodge – Dead House Interior, looking south through the original building towards the interior of the shed addition. Note removal of the south wall has created a larger space. 08/16/2017. KSHS/Anderson, Rick.

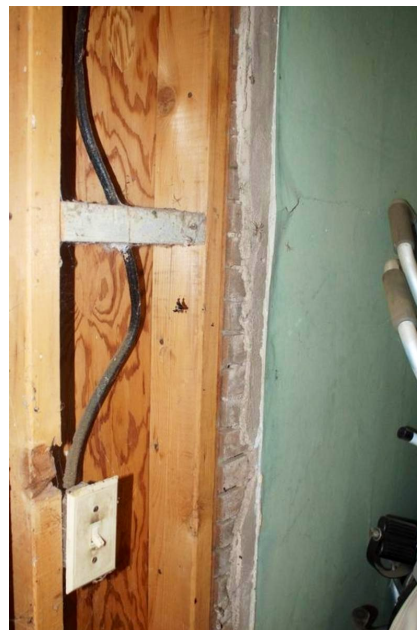
S5-008: Fort Dodge – Dead House (Relocated). Installation of faulty wiring & removal of wall.
