Historic Buildings/Structures Survey and Condition Assessment Associated with the Santa Fe Trail in Kansas

*Last Chance Store (ca. 1857)
Council Grove, Morris County, KS*

Report submitted to the
National Trails Intermountain Region, National Park Service; Santa Fe, NM

Rick Anderson
National Register Historian
Cultural Resources Division
Kansas Historical Society
Topeka, KS
December 2017

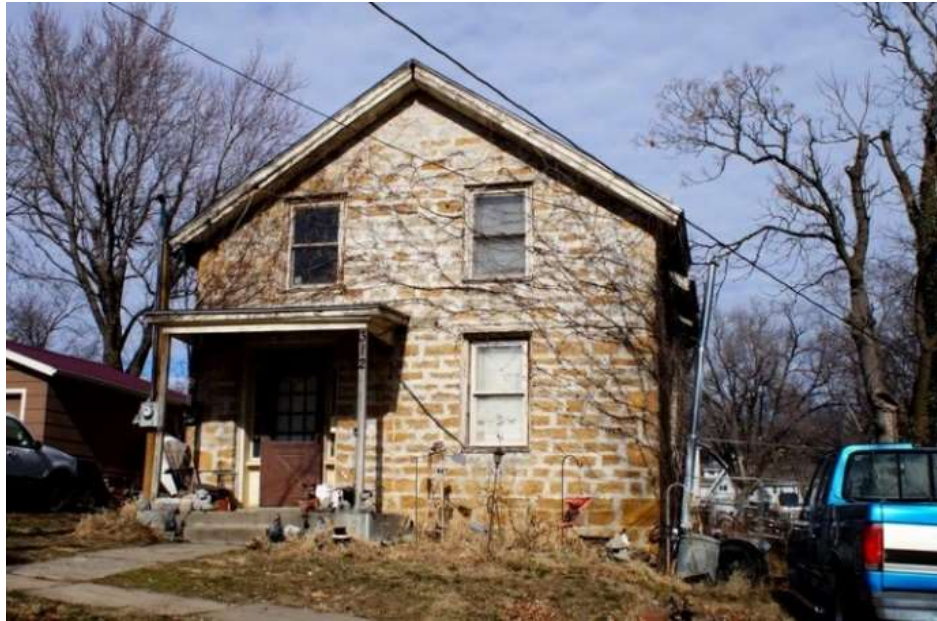
001: Mitchell, Thomas W., House (KHRI: 139-365) South (front) elevation; looking north-northwest.

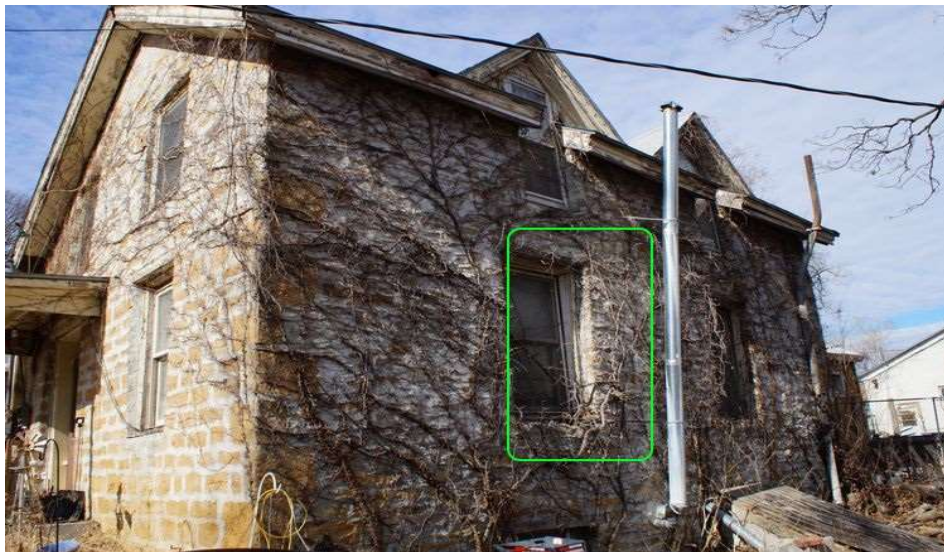
Until the 2016-2017 Kansas – Santa Fe Trail Building Survey project was undertaken, this privately-owned residence had never been surveyed for the Historic American Buildings Survey (HABS)¹³ nor for the KHRI database. The center of the east wall is bowing outward approximately 2-3 inches between the two windows. In the past the foundation below that area had been altered. A heating stove exhaust vent pipe exits through a hole drilled in the limestone foundation. The wall is bowing outward

002: Mitchell, Thomas W., House (KHRI: 139-365) East elevation; looking northwest. Wall is bowing outward just right of the left window. Here the sun is shining on the protruding portion [circled in green] of the wall and to the left of the vent pipe. Note also the amount and size of the vines growing on the house in this area.

just above the vent pipe; which may have further caused structural problems for the east wall. Recommendations: remove the ivy vines attached to all elevations of the house. The vines are old, large and growing in the mortar gaps. During the summer months the west elevation is totally obscured by the vines. A historical architect should be contacted to evaluate the house overall and the condition of the foundation and wall stones in the area where the east wall is bowing out

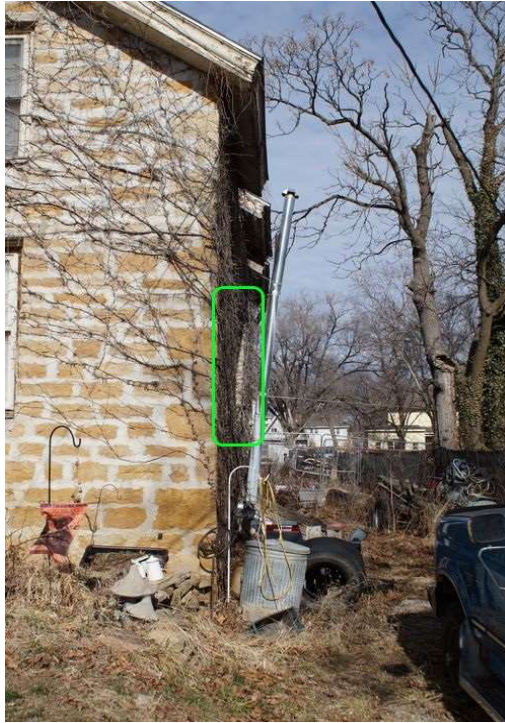
003: Mitchell, Thomas W., House (KHRI: 139-365) Southeast corner of building; looking north. The area of the damaged wall is circled in green. The area is also highlighted by the sun shining on just that area. Note the heating stove vent pipe is purposely installed at that angle to clear the roof overhang.

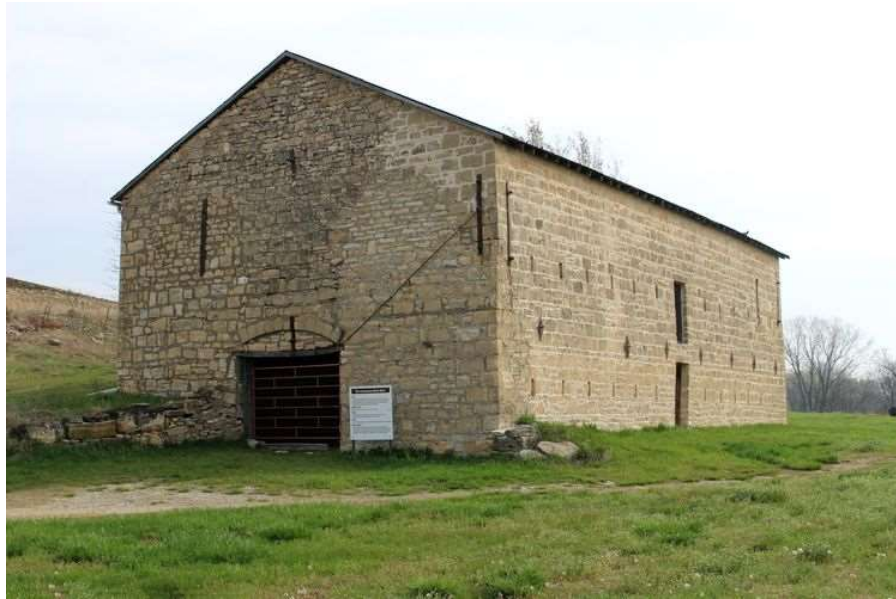
001: Morris: Big John Farm Limestone Bank Barn (KHRI: 127-0000-00040) West and south elevations; looking northeast.

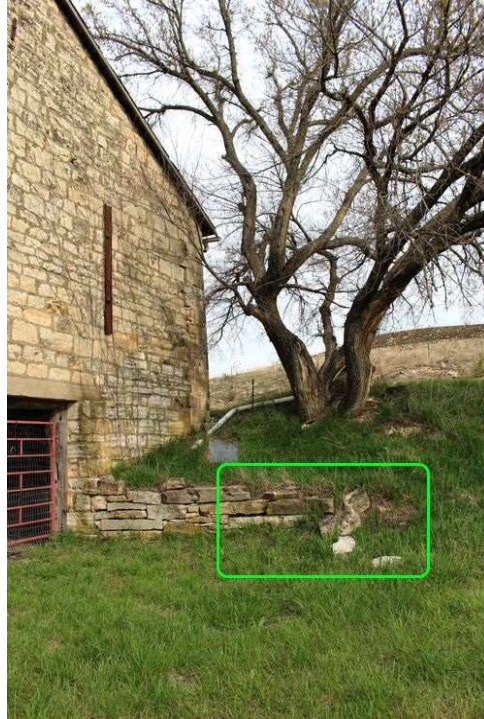
Second and third concerns: east and west elevation wing-walls being pushed inward. (See photo #004 west elevation, north wing-wall and photo #005 east elevation, north wing-wall.) This condition has been further aggravated by excessive water intrusion from the missing gutter downspout on the northeast side of the roof. Half of all the water on the north side of the roof eventually drains behind the barn's north side foundation and the east wing-wall.

005: Morris: Big John Farm Limestone Bank Barn (KHRI: 127-0000-00040) Looking north at the east elevation's north wing-wall. Area of green box indicates the wall being overtaken by dirt and hydrostatic pressure moving the stones. Note large tree growing too close to the barn and wing-wall.

Recommendations: after the foundation and hydrostatic problems are corrected the wall stones may have to be reset in the gables and the south elevation. Masonry repairs and repointing should follow the guidance in Preservation Brief #2 - "The Repointing Mortar Joints in Historic Masonry Buildings". The large elm tree growing too close to the foundation and the wing-wall at the northeast corner of the barn should be removed. Refer to the NPS Preservation Brief #35 or contact the Kansas SHPO at (785) 272-8681 ext. 240.

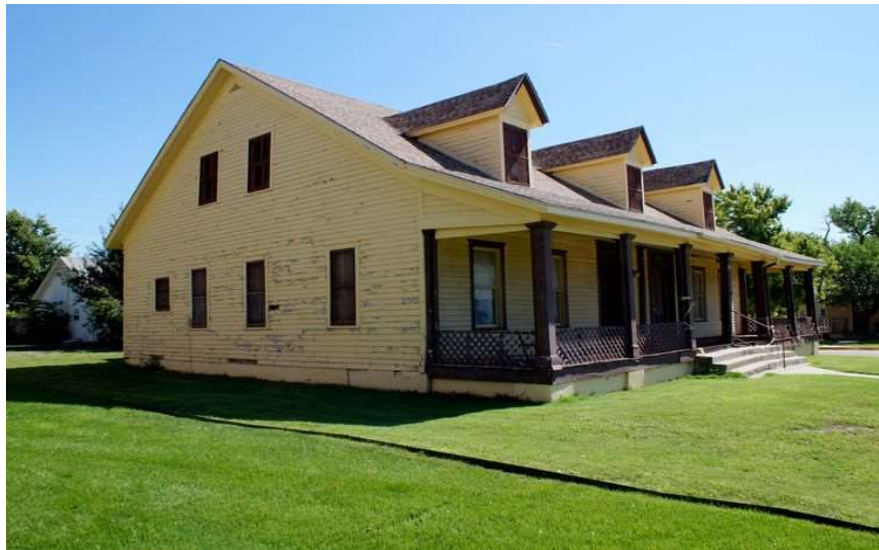
001: Fort Dodge Junior Officers' Quarters ca. 1870 (KHRI: 057-1426). West and south (front) elevations; looking northeast.

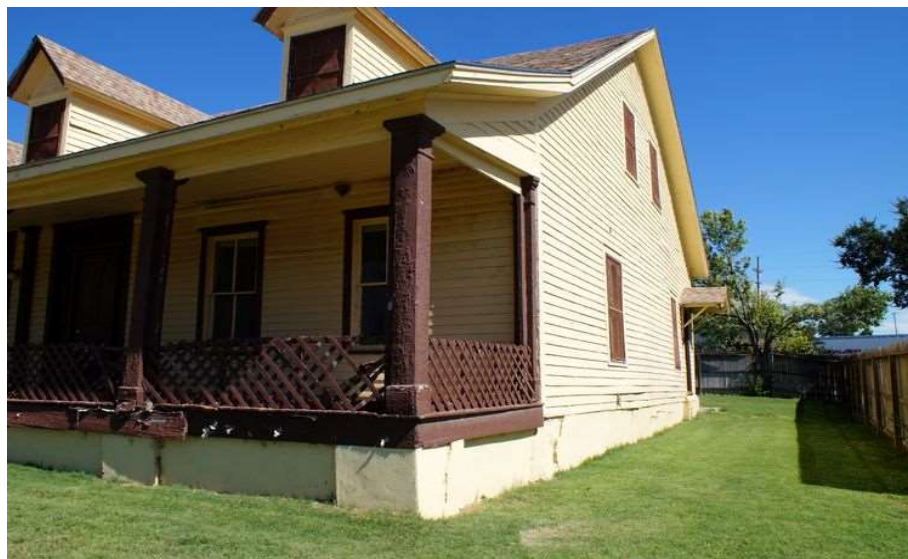
002: Fort Dodge Junior Officers' Quarters ca. 1870 (KHRI: 057-1426). South (front) and east elevations; looking north-northwest.

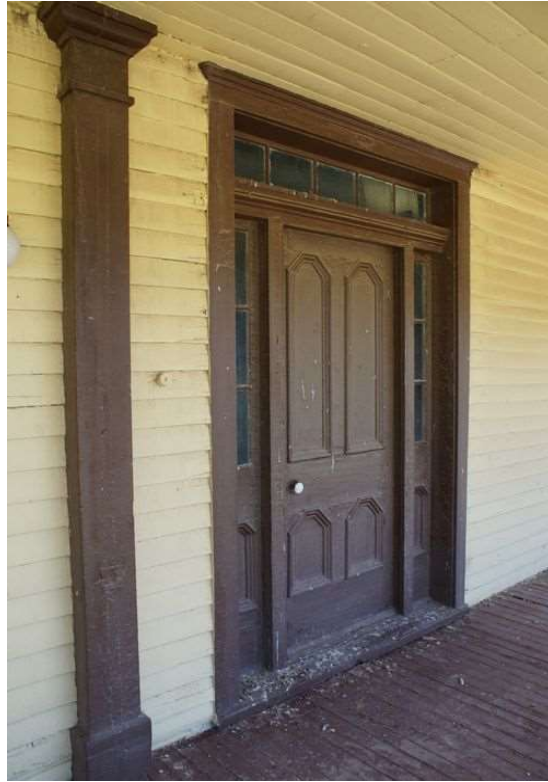
003: Fort Dodge Junior Officers' Quarters ca. 1870 (KHRI: 057-1426). South (front) elevation, primary entrance to the east side of Junior Officers' Quarters; looking northeast.

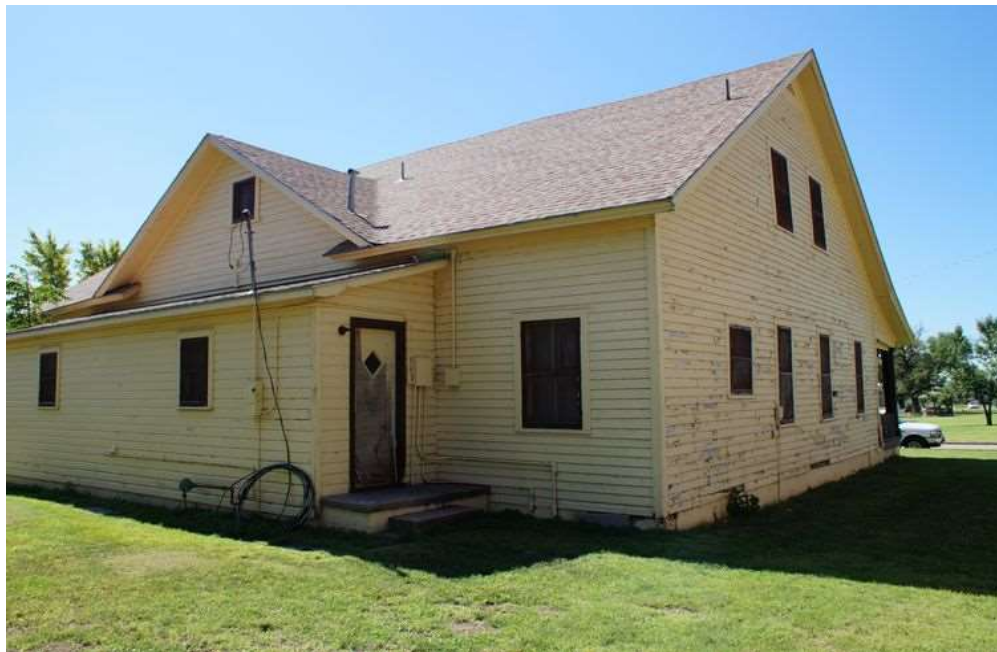
004: Fort Dodge Junior Officers' Quarters ca. 1870 (KHRI: 057-1426). North and west elevations: looking south-southeast.

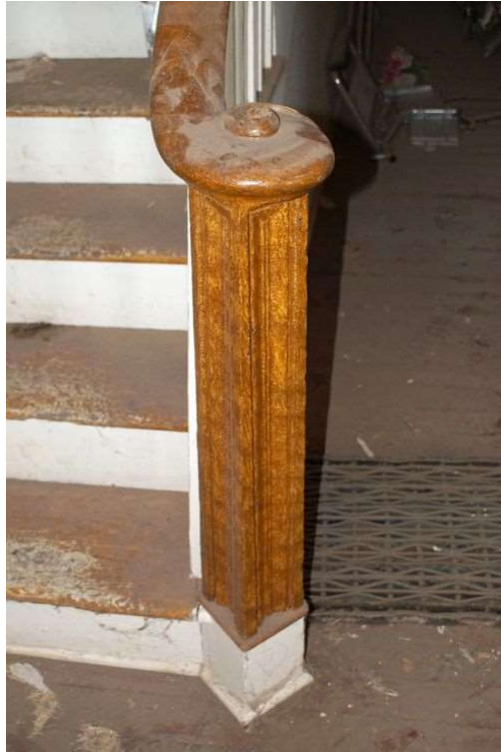
005: Fort Dodge Junior Officers' Quarters ca. 1870 (KHRI 057:-1426). First-floor, east side of Junior Officers Quarters; details of the lower newel post and hand rail; looking north.

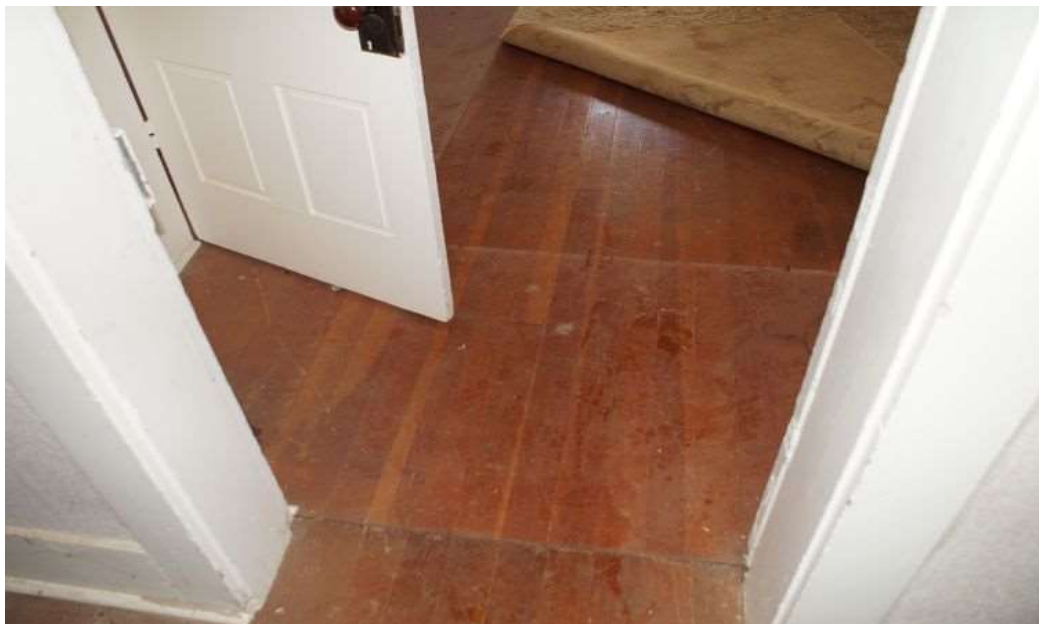
Dodge paying considerable attention to the Junior Officers' Quarters. The wood-framed building does require repair and maintenance. The roof has been replaced but there is water coming around some of the windows into the walls. The floor in the corner of the northeast room has settled in the area of the water intrusion. See condition assessment and KHRI photos for more information. A general consensus was concluded the day of the visit that the building could be saved. The final decision rests with the owners. [Update: the building was still extant as of August 1, 2018. See most recent photos on KHRI.]

006: Fort Dodge Junior Officers' Quarters ca. 1870 (KHRI: 057-1426). Second-floor, west side of Junior Officers Quarters; view of current hardwood floor condition.

Recommendations: Ultimately try to avoid demolition. First, determine how to stabilize the conditions. Then begin by repairing those things that jeopardize the building as a whole. Consider options for alternative uses and continue with repairs and maintenance as budgets allow. Refer to the NPS Preservation Brief #35 or contact the Kansas SHPO at (785) 272-8681 ext. 240.

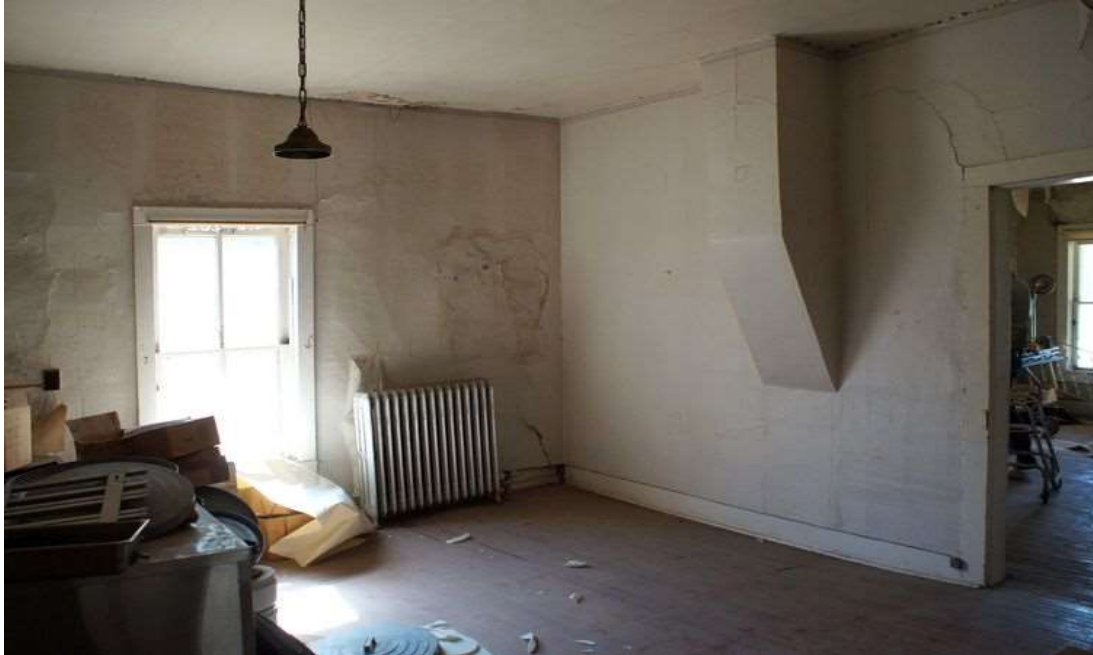
007: Fort Dodge Junior Officers' Quarters ca. 1870 (KHRI: 057-1426). Interior, first-floor east half of Junior Officers Quarters; looking southeast in the northeast room. The wall with the window is the area of water intrusion. Note plaster above register and to the right of the window.

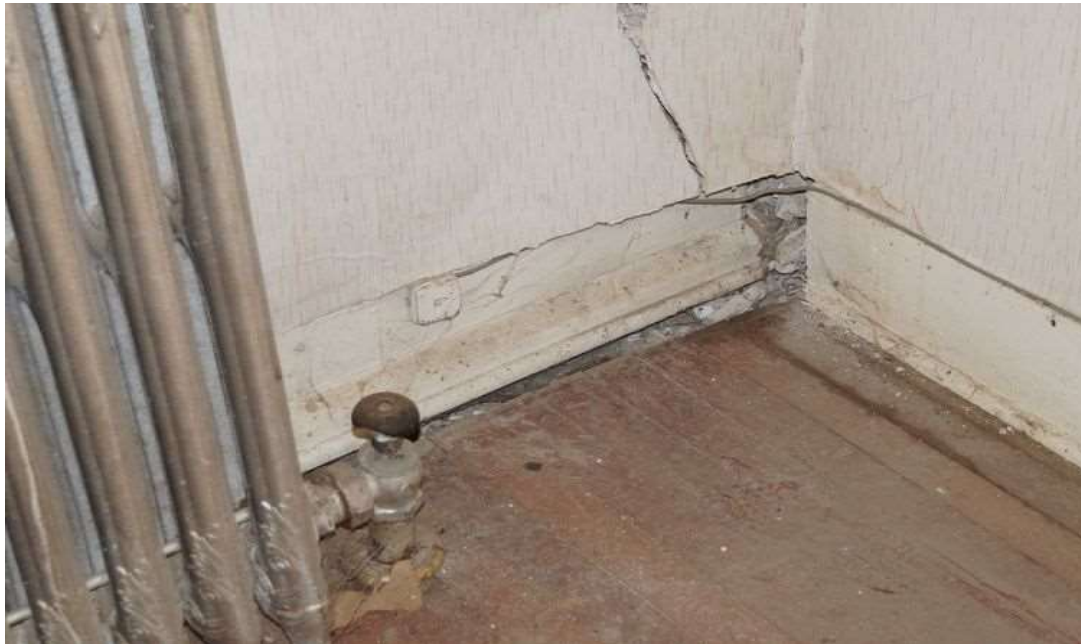
008: Fort Dodge Junior Officers' Quarters ca. 1870 (KHRI: 057-1426). First-floor, east side of Junior Officers Quarters; water damage and settling of the floor from the wall in the northeast corner of the northeast room.

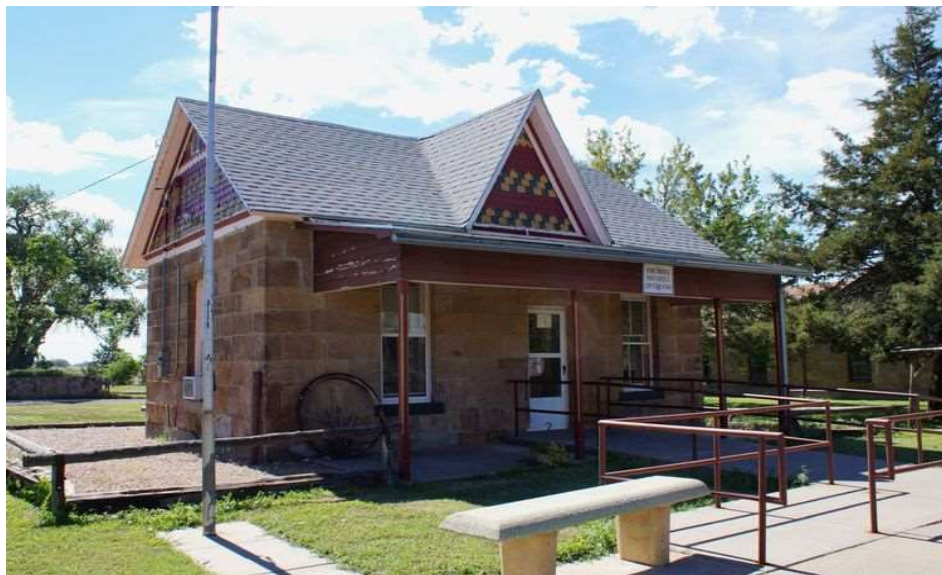
001: Fort Dodge Officers House ca. 1867 (KHRI: 057-1821-00005). West elevation; looking east.

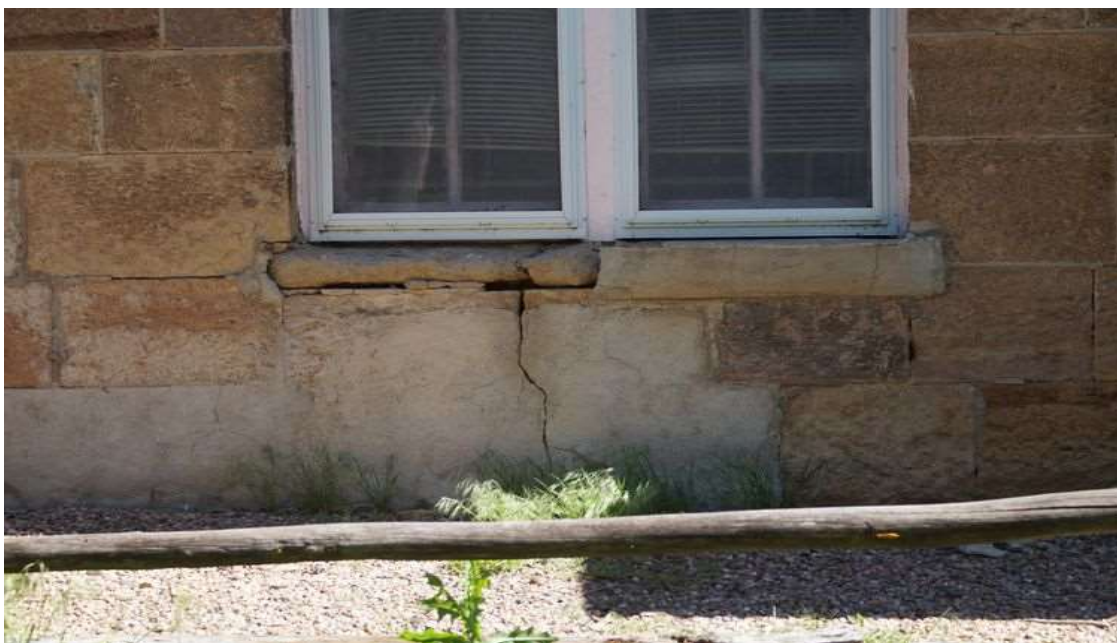
002: Fort Dodge Officers House ca. 1867 (KHRI: 057-1821-00005). South elevation windows; looking north. Concrete filled under window with damaged sill.

Create a plan before inspecting the areas having the inappropriate treatments. Prior to inspecting the buildings, develop a plan asking what would be done if removing the material does not create further problems? What hidden conditions may require repair and how would the repair be undertaken? If the original stones are damaged beyond repair; determine what could be done next. Note: avoid pressurized or abrasive cleaning methods.

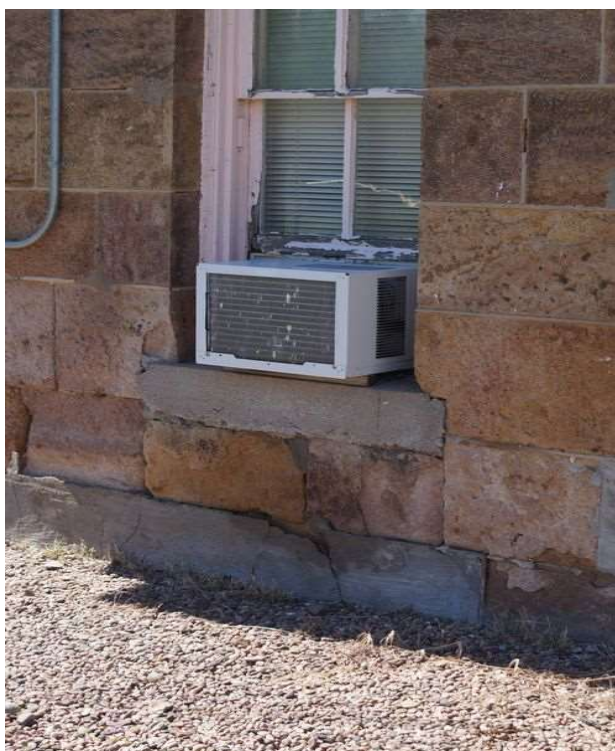
003: Fort Dodge Officers House ca. 1867 (KHRI: 057-1821-00005). North elevation window and a replaced, concrete window sill; looking southeast.

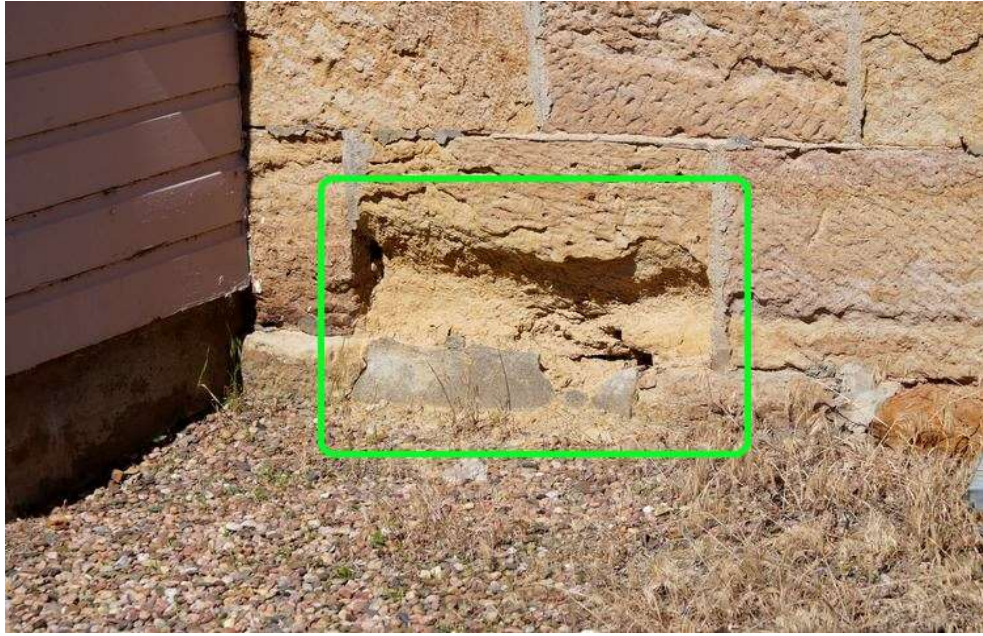
004: Fort Dodge Officers House ca. 1867 (KHRI: 057-1821-00005). East elevation at ground level; looking west. Approximately one-half of the stone's face has spalled away. Note concrete in area.

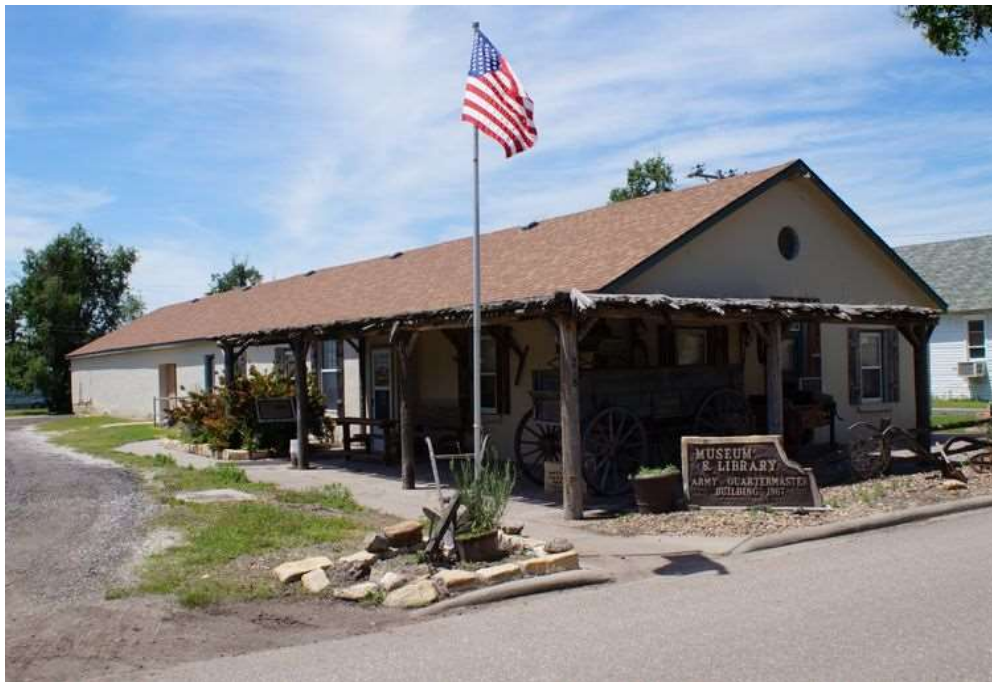
001: Fort Dodge Army Quartermaster Building ca. 1867 (KHRI: 057-1399). East (front) and north elevation; looking southwest.

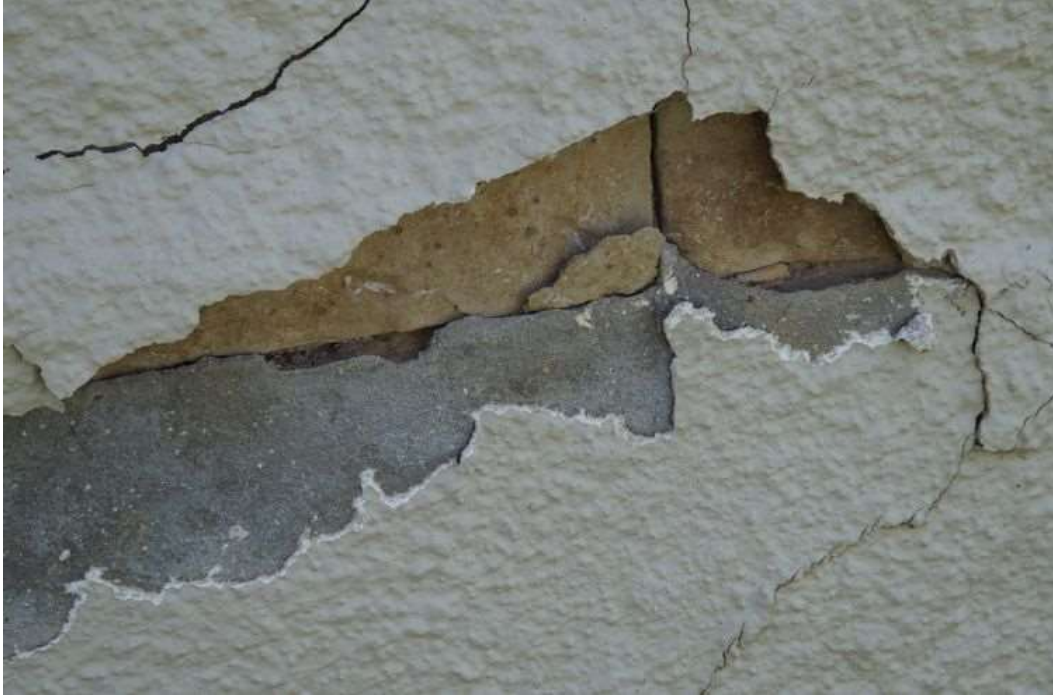
002: Fort Dodge Army Quartermaster Building ca. 1867 (KHRI: 057-1399). West elevation; looking east. Note the application of concrete first under the second attempt with stucco.

Inspect the areas of the gunite (Enlisted Men's Barracks) or stucco (Quartermaster Building) to begin with as these two buildings have experienced the most damage. Do an inspection in an inconspicuous area such as the back of a building. Initially do not remove too much material. Avoid damaging the stone underneath. Determine the extent of the damage and if removing the materials would create more problems. Refer to the NPS Preservation Brief #35 or contact the Kansas SHPO at (785) 272-8681 ext. 240.

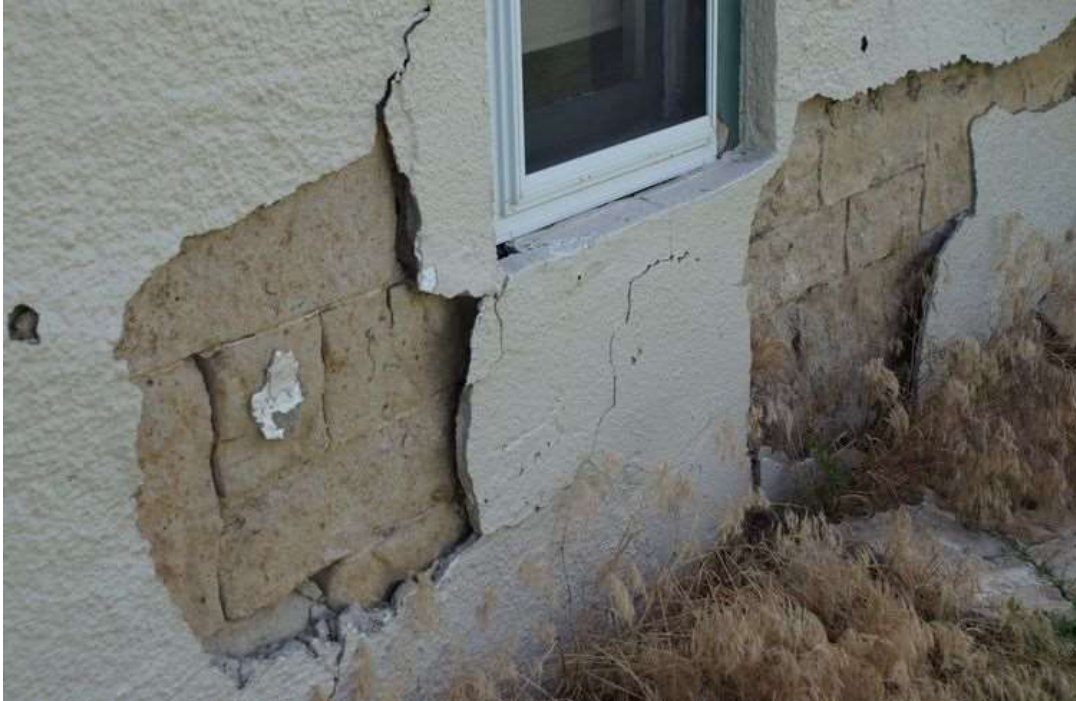
003: Fort Dodge Army Quartermaster Building ca. 1867 (KHRI: 057-1399). West elevation; looking southeast.

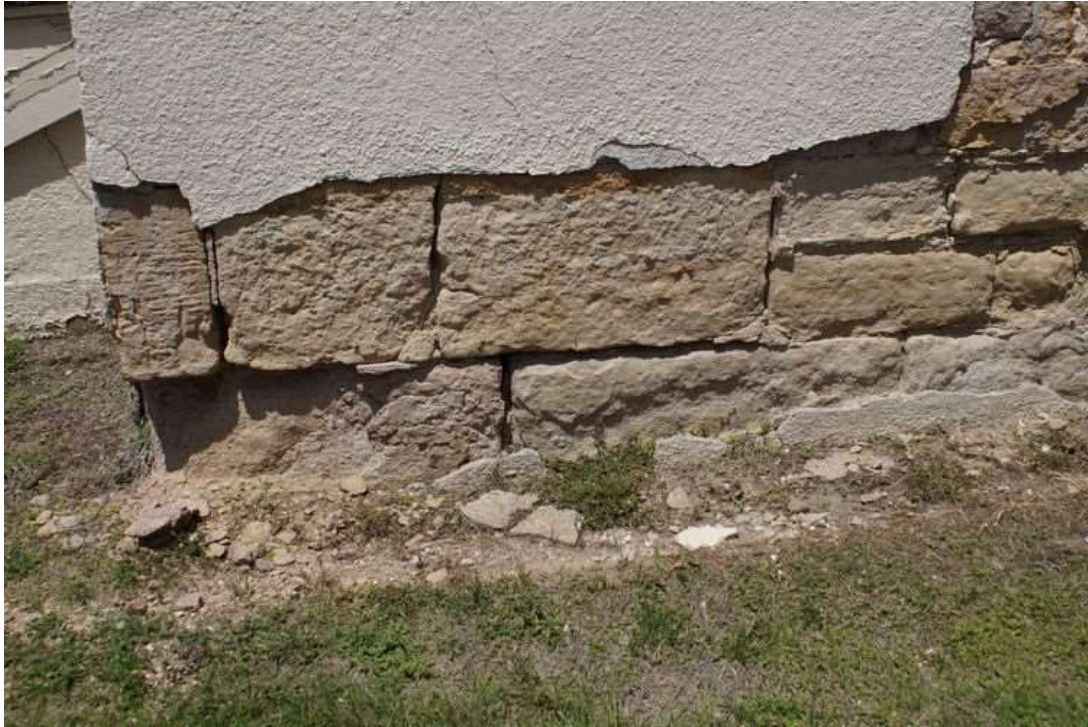
004: Fort Dodge Army Quartermaster Building ca. 1867 (KHRI: 057-1399). East elevation at southeast corner of building; looking west. Note bottom corner stone has totally spalled.

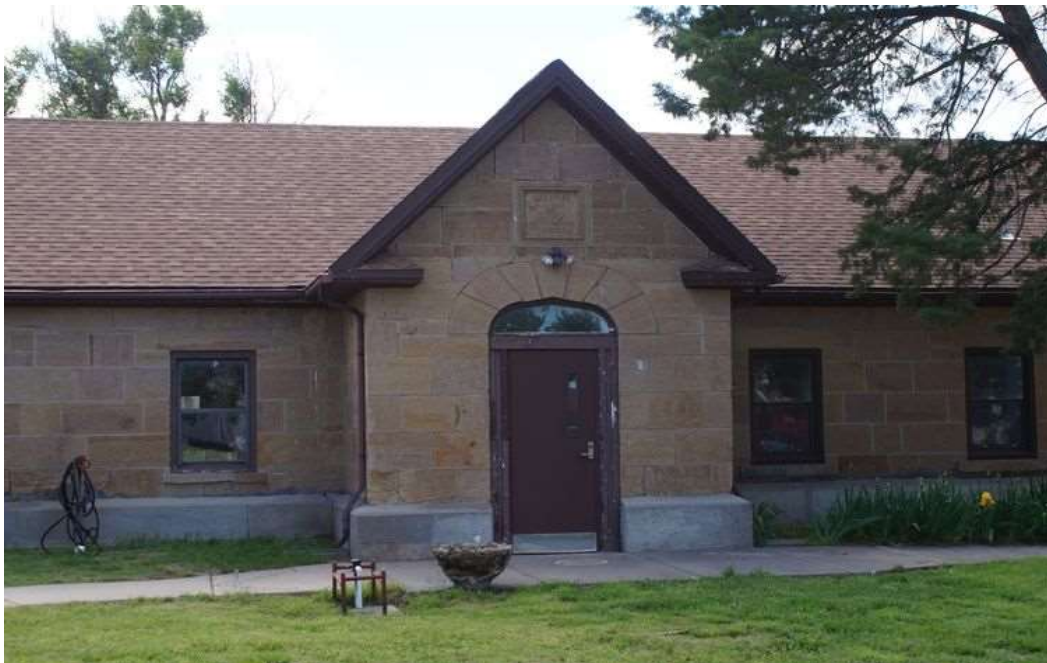
001: Fort Dodge Enlisted Men's Barracks ca. 1867 (KHRI: 057-1821-00003). West (front) elevation of south barracks; looking northeast.

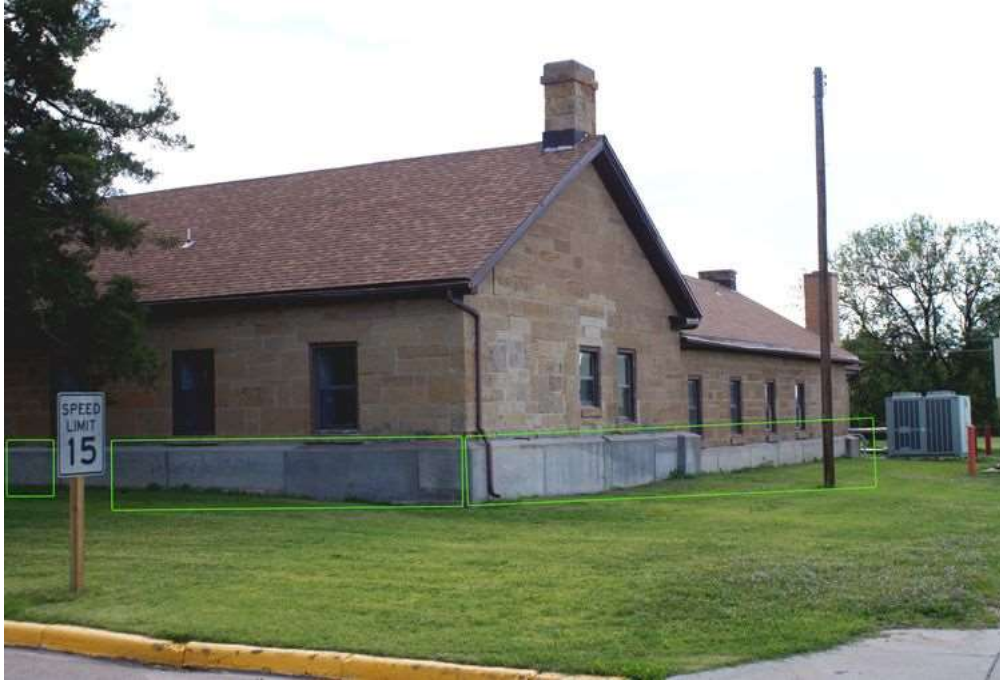
002: Fort Dodge Enlisted Men's Barracks ca. 1867 (KHRI: 057-1821-00003). South end of south barracks at the west (front) and south elevations; looking northeast. Note application of concrete/gunite at base of walls that encompasses the entire building; shown here in green.

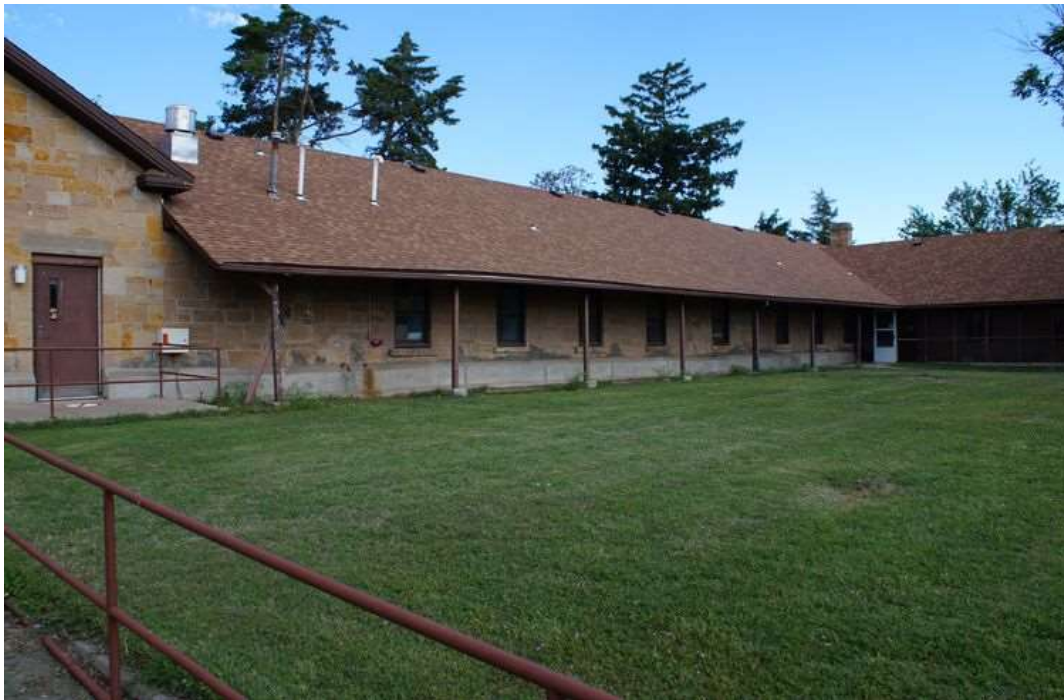
003: Fort Dodge Enlisted Men's Barracks ca. 1867 (KHRI: 057-1821-00003). East elevation of north barracks; looking northwest.

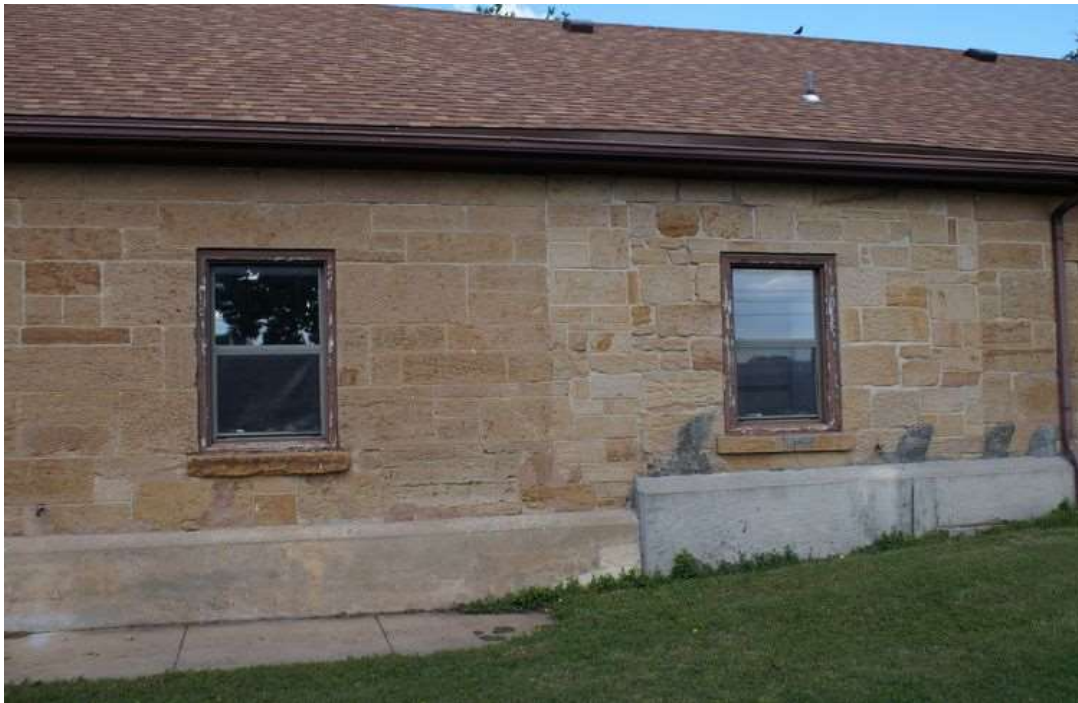
004: Fort Dodge Enlisted Men's Barracks ca. 1867 (KHRI: 057-1821-00003). East elevation of south barracks; looking west. Note two different applications of concrete/gunite to lower areas of the walls.

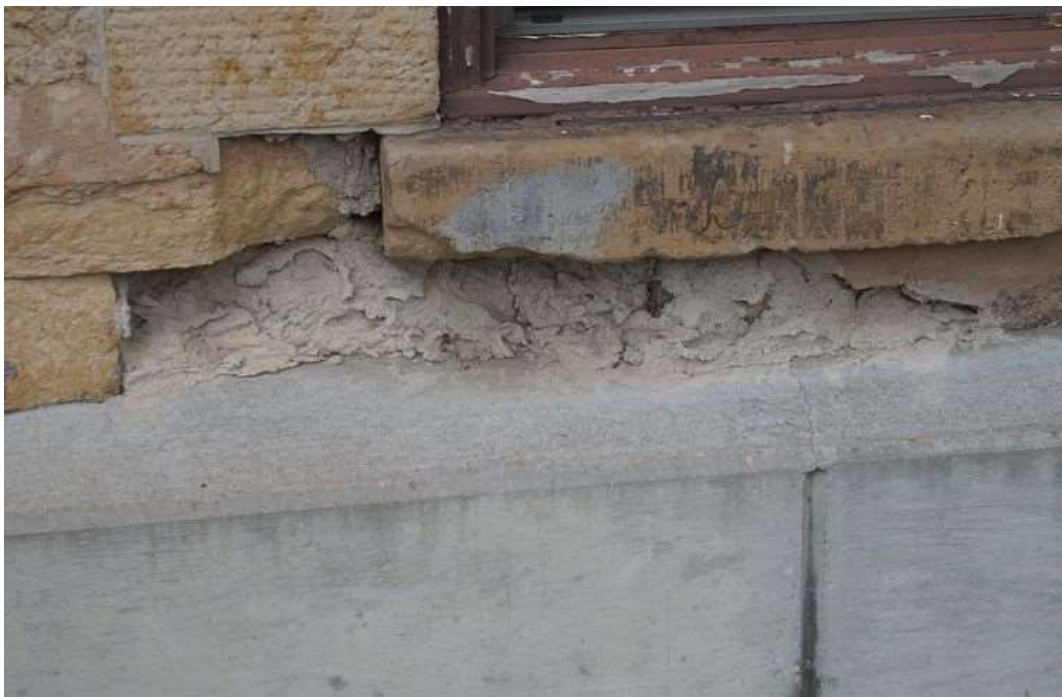
005: Fort Dodge Enlisted Men's Barracks ca. 1867 (KHRI: 057-1821-00003). South barracks east elevation, typical window sill and spalled sandstone just above the concrete/gunite; looking west.

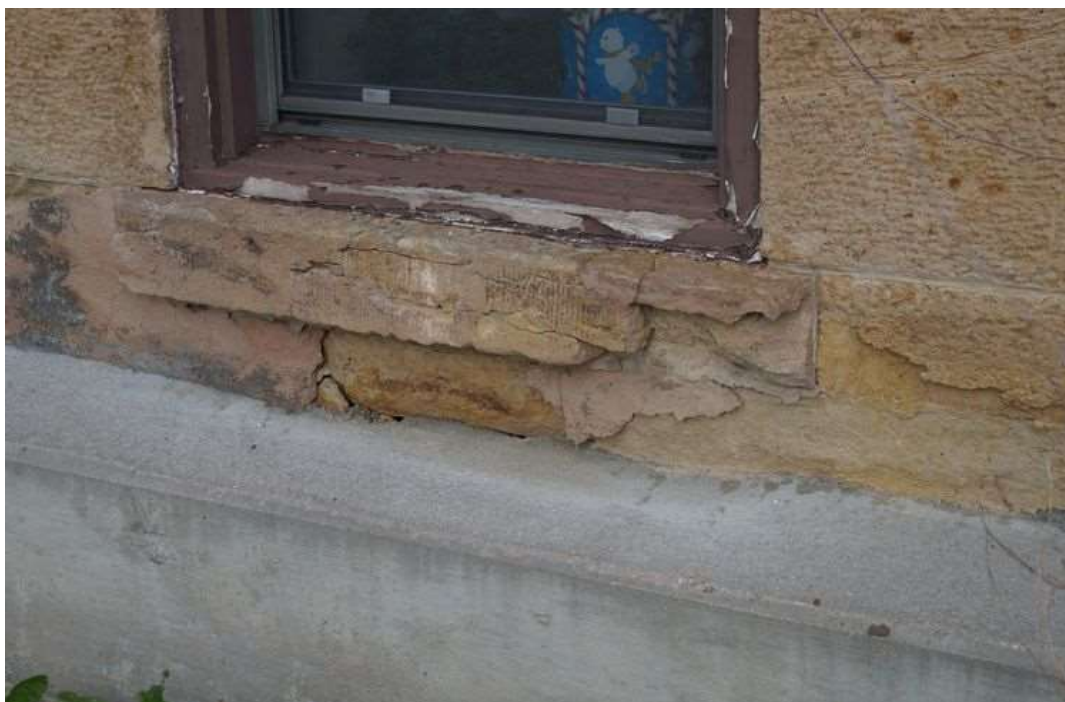
006: Fort Dodge Enlisted Men's Barracks ca. 1867 (KHRI: 057-1821-00003). Sandstone window sill and concrete/gunite application on east elevation of south barracks; looking west.

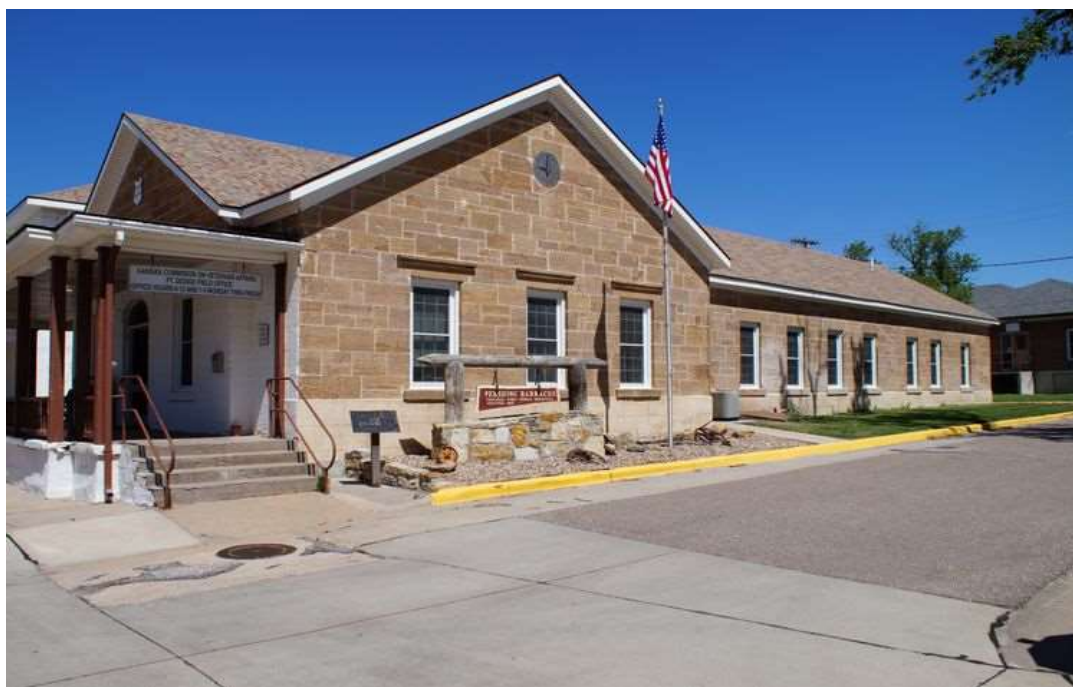
001: Old Fort Dodge Hospital ca. 1867 (KHRI: 057-1821-00004). South (front) and east elevations; looking northwest.

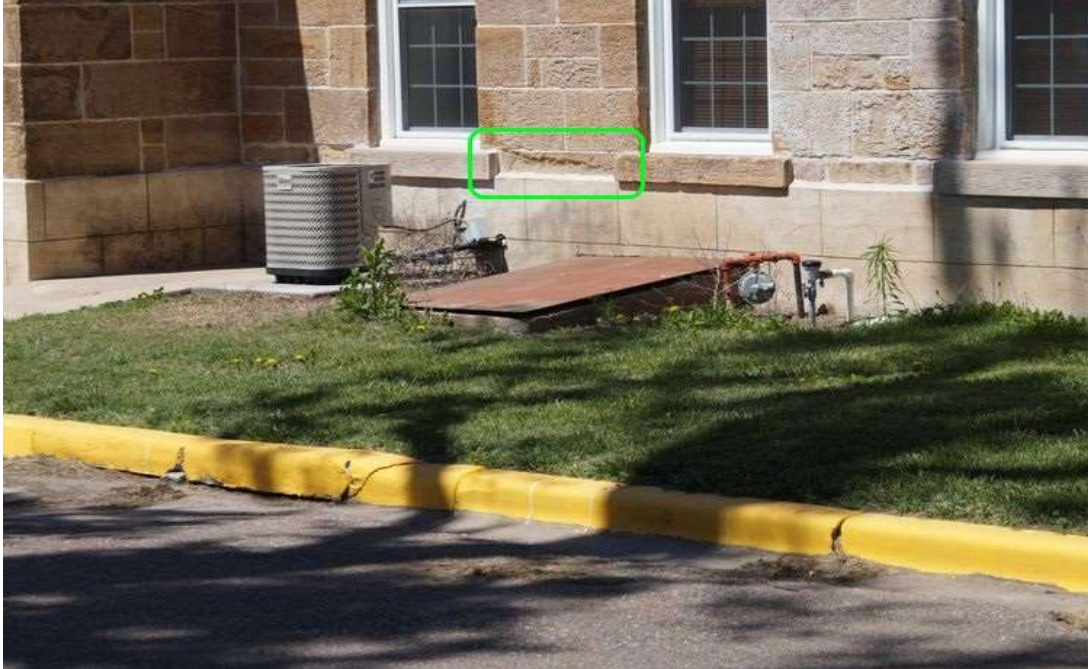
002: Old Fort Dodge Hospital ca. 1867 (KHRI: 057-1821-00004). East elevation exterior basement access; looking west-southwest. Note: spalling of the sandstone above the veneer panels is shown in the green box.

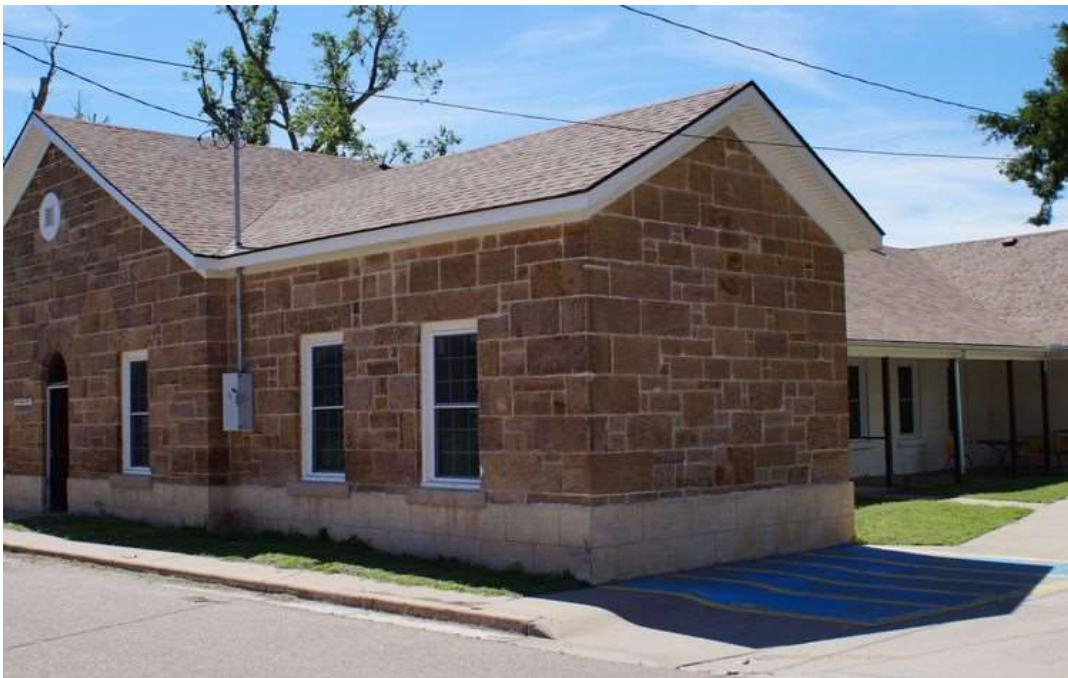
003: Old Fort Dodge Hospital ca. 1867 (KHRI: 057-1821-00004). North and west elevation of what was originally the kitchen wing; looking southeast. Veneer panels continue along the side elevations to the rear elevations.

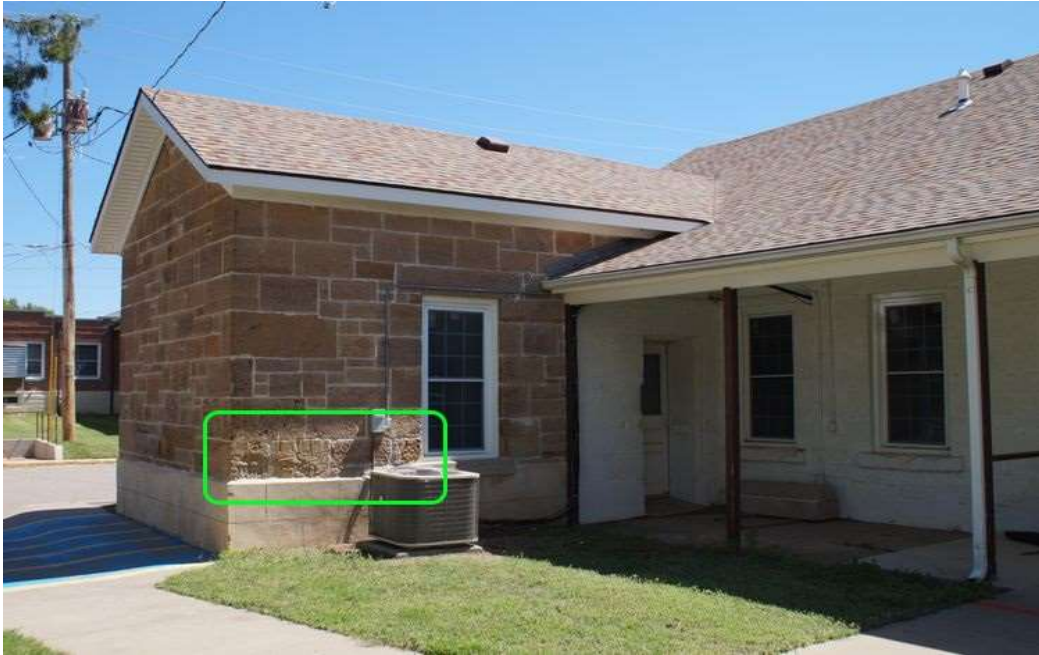
004: Old Fort Dodge Hospital ca. 1867 (KHRI 1821-1821-00004). West and south elevation of what was originally the kitchen wing; looking north-northeast. Note: spalling of the sandstone above the veneer panels is shown in the green box.

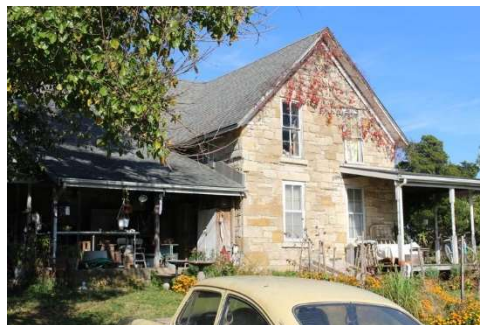
KHRI #: 091-1480-00004 [Johnson Co.]
 Historic name: McCarthy, John, House
 Date of construction:
 Architectural integrity: Severe deterioration
 Architectural integrity notes: Water intrusion, wall damage, damaging vegetation
 Association w/trail: *IND* 1.2 miles S of SFT
 WGS-84: 38.770660 -95.001842
 SR/NR eligibility: NR listed: 07/10/2000

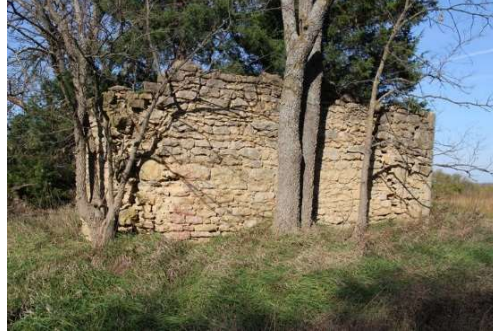
KHRI #: 045-0000-00362 [Douglas Co.]
 Historic name: Prairie City Catholic Mission (Ruins)
 Date of construction: 1859
 Architectural integrity: Severe deterioration
 Architectural integrity notes: The only extant walls
 are the west and ½ of the north wall.
 Association w/trail: IND 2.0 miles S of SFT
 WGS-84: Redacted [location on file with the KS-SHPO]
 SR/NR eligibility: Not assessed

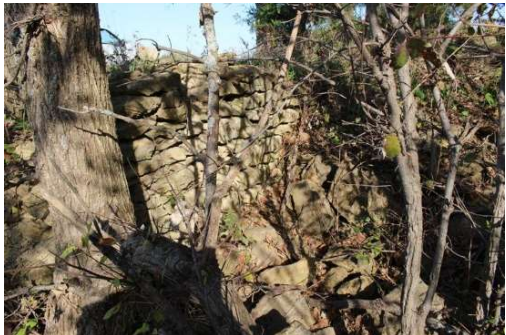
KHRI #: 045-0000-00003 [Douglas Co.]
 Historic name: Prairie City Pastoral Res. (Ruins)
 Date of construction: 1872
 Architectural integrity: Severe deterioration
 Architectural integrity notes: Extant remains
 are lower 1-2' of walls and basement.
 Association w/trail: *IND* 2.0 miles S of SFT
 WGS-84: Redacted [on file with the KS-SHPO]
 SR/NR eligibility: Not assessed
