Historic Buildings/Structures Survey and Condition Assessment Associated with the Santa Fe Trail in Kansas

*Last Chance Store (ca. 1857)
Council Grove, Morris County, KS*

Report submitted to the
National Trails Intermountain Region, National Park Service; Santa Fe, NM

Rick Anderson
National Register Historian
Cultural Resources Division
Kansas Historical Society
Topeka, KS
December 2017

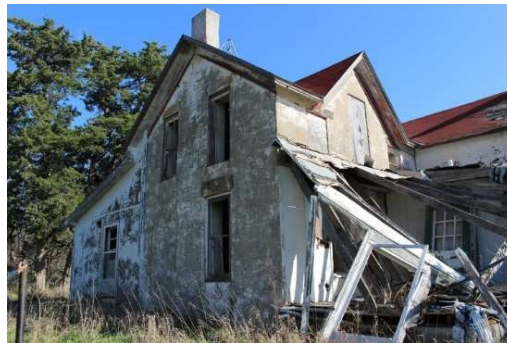
KHRI #: 045-0000-00365 [Douglas Co.]
 Historic name: Meunier (Miller), George, House
 Date of construction: 1861
 Architectural integrity: Severe deterioration
 Architectural integrity notes: House has suffered
 severe water intrusion. Slated for demolition.
 Association w/trail: IND 2.1 miles S of SFT
 WGS-84: Redacted [on file with the KS-SHPO]
 SR/NR eligibility: Not assessed

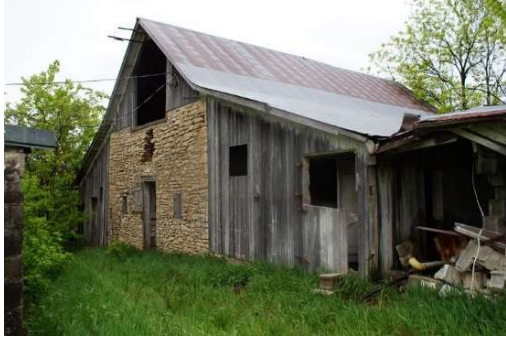
KHRI #: 045-0000-00367 [Douglas Co.]
 Historic name: Meunier (Miller), George, Barn
 Date of construction: 1865
 Architectural integrity: Severe deterioration
 Architectural integrity notes: Has additions;
 large hole in south, front elevation
 Association w/trail: *IND* 2.1 miles S of SFT
 WGS-84: Redacted [on file with the KS-SHPO]
 SR/NR eligibility: Not assessed

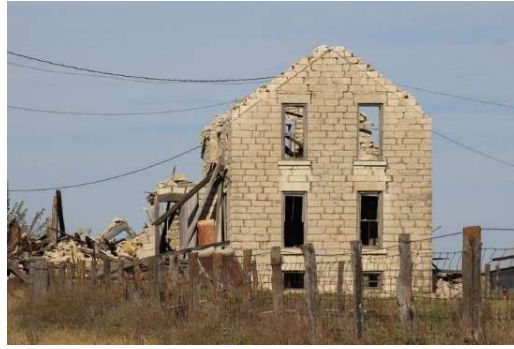
KHRI #: 045-0000-00015 [Douglas Co.]
 Historic name: Simmons Point (Ruins)
 Date of construction: 1870
 Architectural integrity: Severe deterioration
 Architectural integrity notes: Only extant walls
 are portions of the north and south gables.
 Association w/trail: *DIR* .31 miles S of SFT
 WGS-84: 38.783842 -95.434526
 SR/NR eligibility: Not assessed

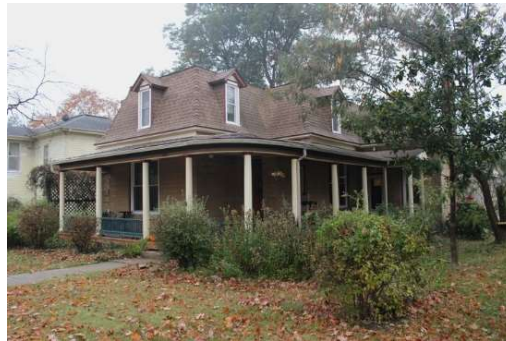
KHRI #: 045-0340-00005 [Douglas Co.]
 Historic name: Hayden, William B., House
 Date of construction: 1869
 Architectural integrity: Moderate changes
 Architectural integrity notes: East elevation
 has 2 or 3 wood-framed additions.
 Association w/trail: IND 1.5 miles SW of SFT
 WGS-84: 38.774587 -95.204400
 SR/NR eligibility: Not assessed

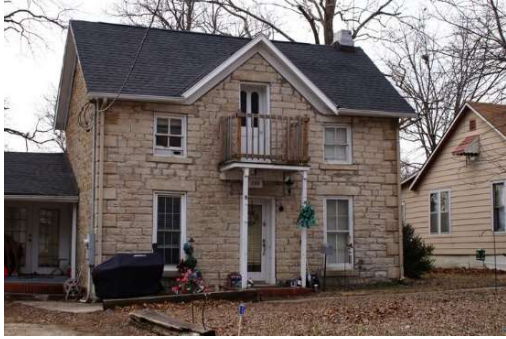
KHRI #: 045-0340-00006 [Douglas Co.]
Historic name: Ebright, Homer, House
Date of construction: 1865-1870
Architectural integrity: Minor changes
Architectural integrity notes: Minor
changes to interior; later rear addition
Association w/trail: *D/R* .87 SE of SFT
WGS-84: 38.776330 -95.189180
SR/NR eligibility: Not assessed

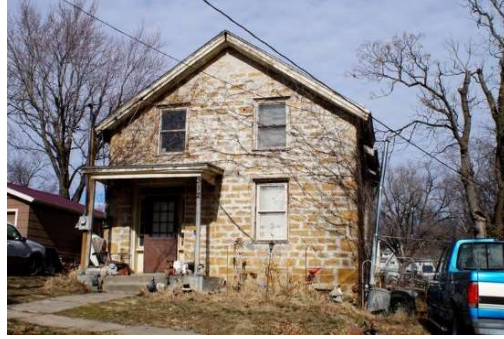
KHRI #: 139-333 [Osage Co.]
 Historic name: Murphy, William, House
 Date of construction: 1865
 Architectural integrity: Minor changes
 Architectural integrity notes: Garage addition on east; south has two porch additions
 Association w/trail: DIR .09 miles S of SFT
 WGS-84: 38.751090 -95.838840
 SR/NR eligibility: Not assessed

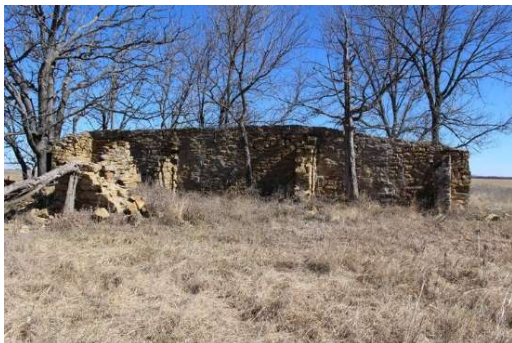
KHRI #: 139-365 [Osage Co.]
 Historic name: Mitchell, Thomas W., House
 Date of construction: 1861
 Architectural integrity: Moderate changes, deterioration
 Architectural integrity notes: one-story add. on north; E el. wall bowing out; damaging vegetation/vines
 Association w/trail: DIR .04 miles S of SFT
 WGS-84: 38.751480 -95.840660
 SR/NR eligibility: Not assessed

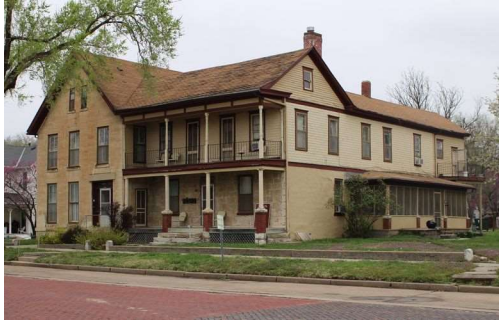
KHRI #: 127-1180-00078 [Morris Co.]
 Historic name: Hebrank, Frederick S., House
 Date of construction: 1864
 Architectural integrity: Moderate changes
 Architectural integrity notes: Second story and porch were added later
 Association w/trail: DIR .02 miles N of SFT
 WGS-84: 38.661910 -96.486260
 SR/NR eligibility: PSIQ received 06/14/2007

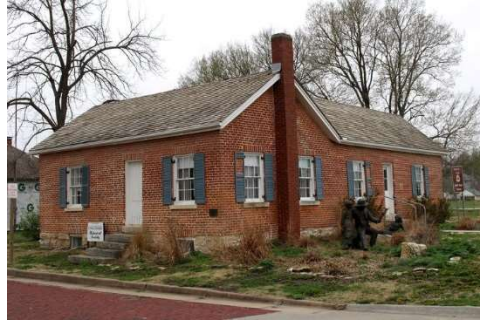
KHRI #: 127-1180-00078 [Morris Co.]
 Historic name: Simcock, Goodson, M., House
 Date of construction: 1860
 Architectural integrity: Moderate changes
 Architectural integrity notes: 1863 additions;
 then later converted to apartments.
 Association w/trail: *DIR* .06 miles N of SFT
 WGS-84: 38.662090 -96.491490
 SR/NR eligibility: NR listed: 08/25/1981

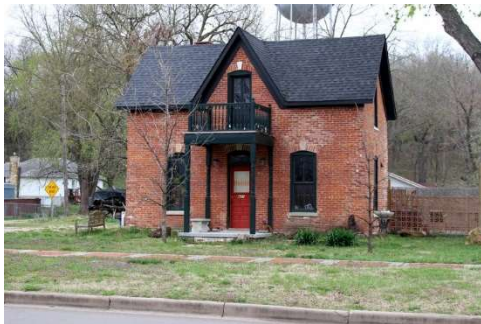
KHRI #: 127-1180-00031 [Morris Co.]
 Historic name: Hays, Seth, House
 Date of construction: 1867
 Architectural integrity: Minor changes
 Architectural integrity notes: S elevation; wood-framed
 shed addition. Restored in 1976.
 Association w/trail: *DIR* .16 miles S of SFT
 WGS-84: 38.659210 -96.488340
 NR listed: 09/25/1975; part of Council Grove NHL

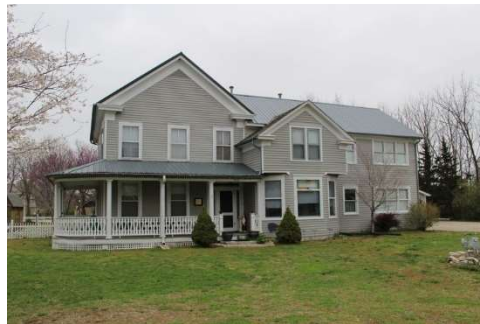
KHRI #: 127-582 [Morris Co.]
 Historic name: Residence [421 N Mission]
 Date of construction: 1862
 Architectural integrity: Moderate changes
 Architectural integrity notes: Interior was
 converted to offices. Has one addition.
 Association w/trail: *DIR* .30 miles N of SFT
 WGS-84: 38.665300 -96.494350
 SR/NR eligibility: Not assessed

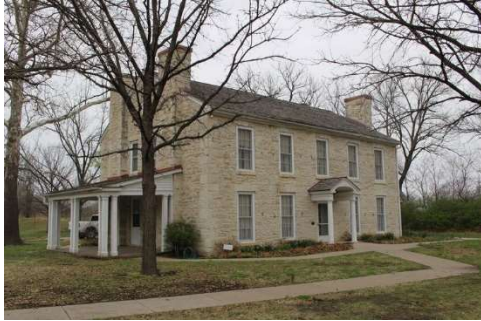
KHRI #: 127-1180-00053 [Morris Co.]
 Historic name: Mather, Jedediah Peck, House
 Date of construction: 1862
 Architectural integrity: Moderate changes
 Architectural integrity notes: Several additions
 and changes to the roof.
 Association w/trail: *DIR* .28 miles N of SFT
 WGS-84: 38.665110 -96.493200
 SR/NR eligibility: State Register listed: 06/12/1984

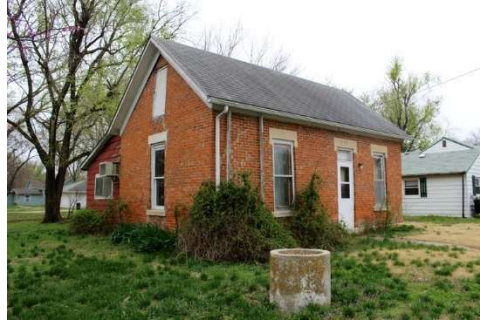
KHRI #: 127-1180-00002 [Morris Co.]
 Historic name: Kaw Methodist Mission
 Date of construction: 1851
 Architectural integrity: Moderate changes
 Architectural integrity notes: Changes to interior; 1855, converted into a home.
 Association w/trail: *DIR* .31 miles N of SFT
 WGS-84: 38.665938 -96.493973
 SR/NR eligibility: NR listed: 07/01/1977

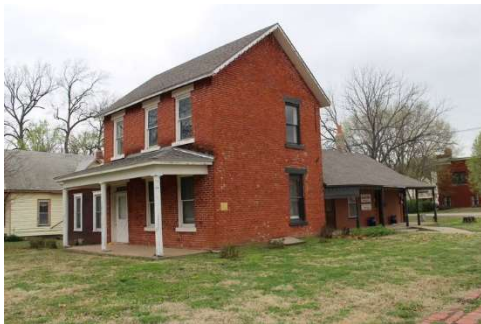
KHRI #: 127-584 [Morris Co.]
 Historic name: Residence [317 Kaw]
 Date of construction: 1866
 Architectural integrity: Minor changes
 Architectural integrity notes: One-story wood-framed shed addition on south elevation.
 Association w/trail: *DIR* .17 miles S of SFT
 WGS-84: 38.656280 -96.490530
 SR/NR eligibility: Not assessed

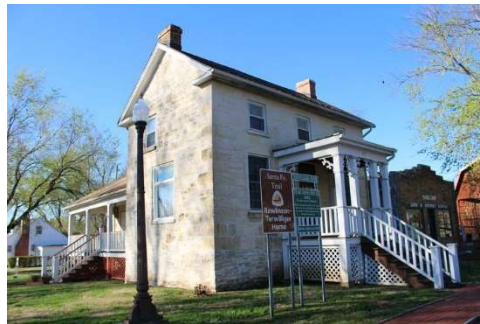
KHRI #: 127-584 [Morris Co.]
 Historic name: Woodworth, Dr. Abner, House
 Date of construction: 1864
 Architectural integrity: Moderate changes
 Architectural integrity notes: Front porch was changed; two west shed additions.
 Association w/trail: *DIR* .08 miles S of SFT
 WGS-84: 38.659760 -96.491780
 SR/NR eligibility: Not assessed

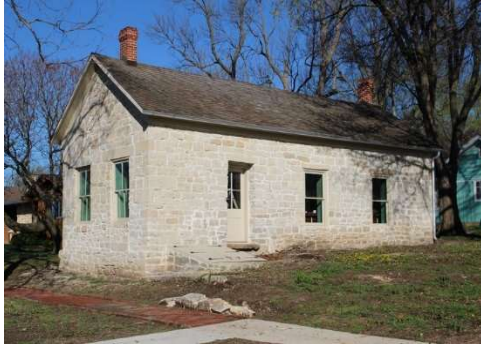
KHRI #: 127-1180-00067 [Morris Co.]
 Historic name: Rawlinson, Abraham and Mary, House
 Date of construction: 1860
 Architectural integrity: Moderate changes
 Architectural integrity notes: House had several changes having had different functions; has original look now.
 Association w/trail: *DIR* located on the SFT
 WGS-84: 38.658510 -96.498830
 SR/NR eligibility: Not assessed

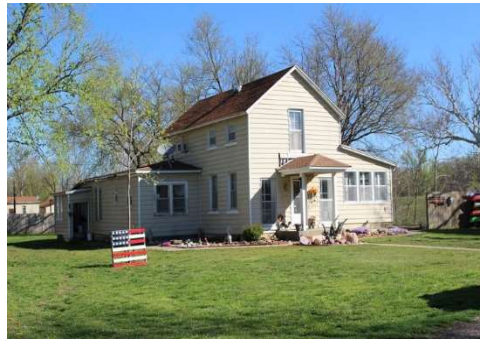
KHRI #: 127-1180-00004 [Morris Co.]
 Historic name: Last Chance Store
 Date of construction: 1857
 Architectural integrity: Moderate changes
 Architectural integrity notes: Changes b/c of numerous functions have been reversed.
 Association w/trail: *DIR* .04 miles S of SFT
 WGS-84: 38.659950 -96.494910
 NR listed: 06/21/1977; updated 05/06/1986
 Part of the Council Grove NHL

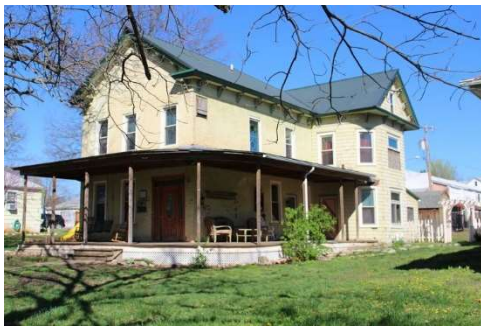
KHRI #: 127-643 [Morris Co.]
 Historic name: Residence [204 W Hays]
 Date of construction: 1862
 Architectural integrity: Moderate changes
 Architectural integrity notes: Has several additions and porches. Covered with aluminum siding.
 Association w/trail: *DIR* .15 miles N of SFT
 WGS-84: 38.663260 -96.492000
 SR/NR eligibility: Not assessed

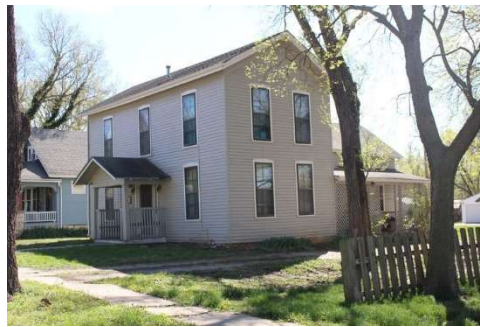
KHRI #: 127-1180-00064 [Morris Co.]
 Historic name: Strieby, C. H. & Caroline, House
 Date of construction: 1864
 Architectural integrity: Moderate changes
 Architectural integrity notes: Two rear shed additions and a wrap-around porch.
 Association w/trail: *DIR* .10 miles S of SFT
 WGS-84: 38.659390 -96.493360
 SR/NR eligibility: Not assessed

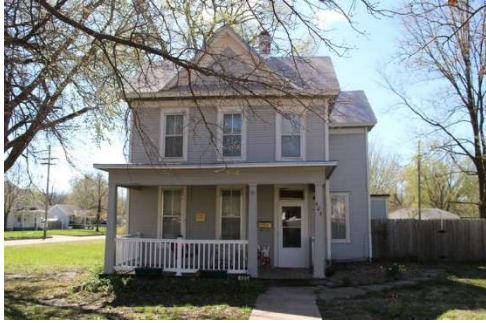
KHRI #: 027-1180-00041 [Morris Co.]
 Historic name: Strieby-Amrine House
 Date of construction: 1868
 Architectural integrity: Minor changes
 Architectural integrity notes: one of seven houses constructed by C. H. Strieby for his family.
 Association w/trail: *DIR* .13 miles S of SFT
 WGS-84: 38.658852 -96.493488
 SR/NR eligibility: Not assessed

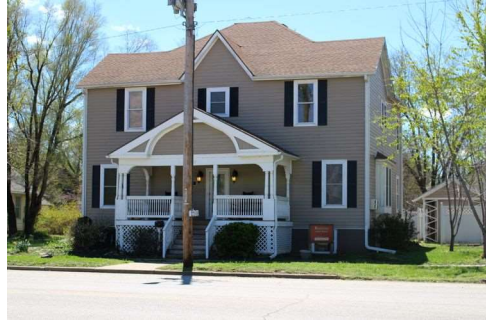
KHRI #: 127-1180-00066 [Morris Co.]
 Historic name: Hughes & Armstrong House
 Date of construction: 1869
 Architectural integrity: Minor changes
 Architectural integrity notes: Vinyl siding;
 1 ½ story wood-framed rear addition
 Association w/trail: *DIR* .13 miles S of SFT
 WGS-84: 38.659050 -96.492980
 SR/NR eligibility: Not assessed

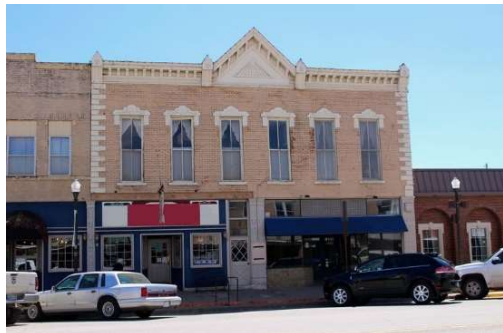
KHRI #: 127-1180-00003 [Morris Co.]
 Historic name: Hays Tavern
 Date of construction: 1863
 Architectural integrity: Moderate changes
 Architectural integrity notes: Changes have been
 reversed; historic photos used for renovations
 Association w/trail: *DIR* located on N side of the SFT
 WGS-84: 38.661430 -96.489850
 NR listed: 10/15/1966. Part of Council Grove NHL and
 contributor to Downtown Council Grove Hist. District.

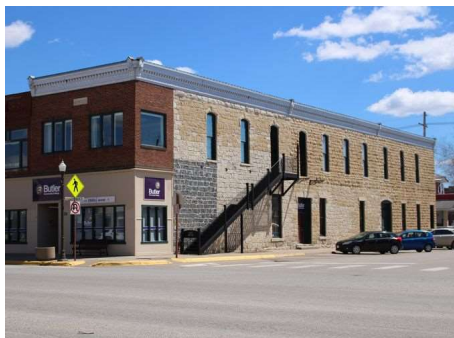
KHRI #: 127-1180-00016 [Morris Co.]
 Historic name: Commercial Building
 Date of construction: 1872
 Architectural integrity: Moderate changes
 Architectural integrity notes: Rear addition;
 changes to int. functions and spaces
 Association w/trail: *DIR* .02 miles S of SFT
 WGS-84: 38.661060 -96.489910
 NR listed: Contributor to the NR district

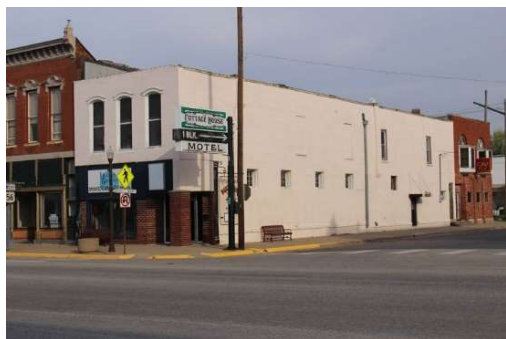
KHRI #: 127-1180-00069 [Morris Co.]
 Historic name: Conn Store
 Date of construction: 1858
 Architectural integrity: Major changes
 Architectural integrity notes: Numerous exterior
 and interior changes
 Association w/trail: *D/R* .02 miles S of SFT
 WGS-84: 38.660950 -96.490260
 NR listed: Non-contributor to the NR district

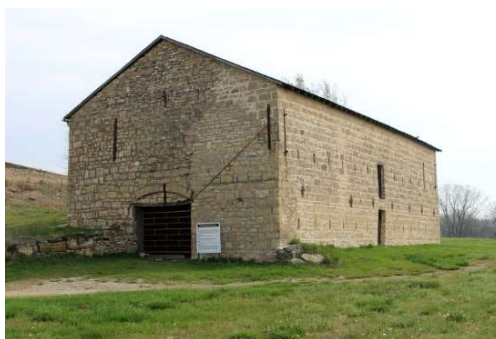
KHRI #: 127-14180-00076 [Morris Co.]
 Historic name: T. S. Huffaker & Co. Building
 Date of construction: 1869
 Architectural integrity: Minor changes
 Architectural integrity notes: Renovations
 to interior as/when functions dictated
 Association w/trail: *DIR* located on the SFT
 WGS-84: 38.661180 -96.490780
 NR listed: Non-contributor to the NR district

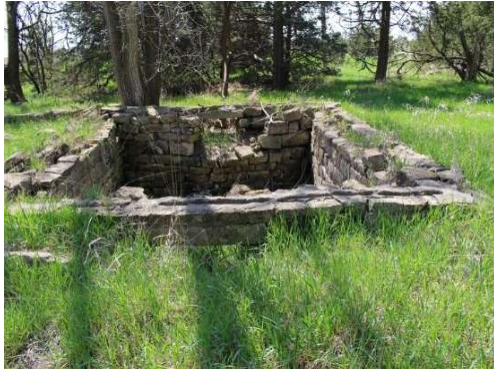
KHRI #: 127-0000-00040 [Morris Co.]
Historic name: Big John Farm Livestock Bank Barn
Date of construction: 1871
Architectural integrity: Minor changes
Architectural integrity notes: 1990s: repairs were made;
now those repairs need major additional attention
Association w/trail: DIR .52 miles N of SFT
WGS-84: 38.670120 -96.449450
SR/NR eligibility: NR listed: 10/25/1990

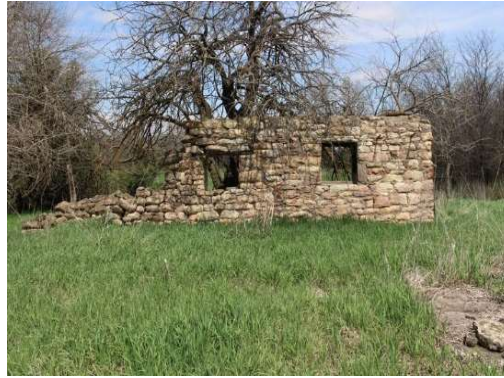
KHRI #: 127-0674-00006 [Morris Co.]
 Historic name: Six-Mile Creek Stage Station
 Date of construction: 1863
 Architectural integrity: Ruins
 Architectural integrity notes: Resources need stabilization; prevent further deterioration
 Association w/trail: *DIR* .11 miles S of SFT
 WGS-84: 38.605030 -96.856190
 SR/NR eligibility: NR listed: 05/11/1995

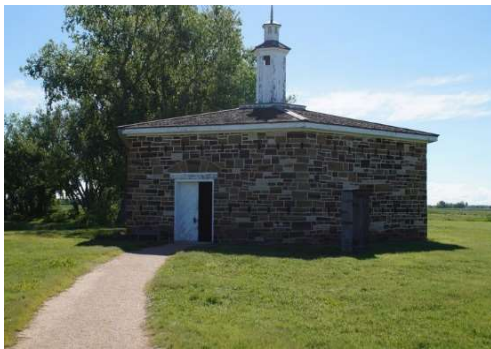
KHRI #: 127-0674-00006 [Morris Co.]
 Historic name: Six-Mile Creek Stage Station: Barn
 Date of construction: 1863
 Architectural integrity: Ruins
 Architectural integrity notes: Site resources need stabilization/ prevent further deterioration
 Association w/trail: *DIR* .11 miles S of SFT
 WGS-84: 38.605260 -96.855640
 SR/NR eligibility: NR listed: 05/11/1995

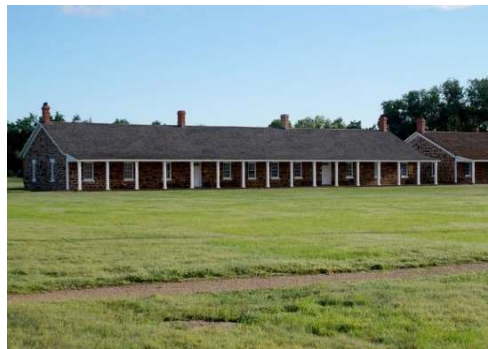
KHRI #: 145-126 [Pawnee Co.]
 Historic name: Fort Larned: Blockhouse
 Date of construction: 1865
 Architectural integrity: Reconstructed
 Architectural integrity notes: Rebuilt on original site with original materials
 Association w/trail: *DIR* located on the SFT
 WGS-84: 38.182890 -99.216460
 NR listed: 10/15/1966 [NHL-1960]

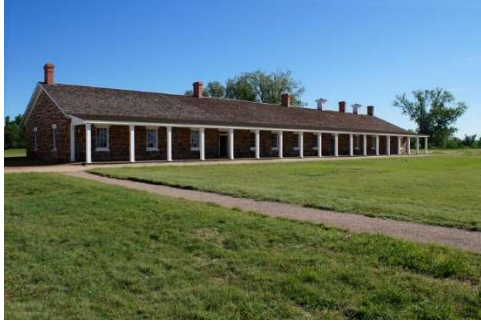
KHRI #: 145-117 [Pawnee Co.]
 Historic name: Fort Larned: Infantry Barracks
 Date of construction: 1865
 Architectural integrity: Minor changes
 Architectural integrity notes: Also serves as the visitors' center, gift shop and fort artifact displays
 Association w/trail: *DIR* located on the SFT
 WGS-84: 38.183700 -99.218580
 NR listed: 10/15/1966 [NHL-1960]

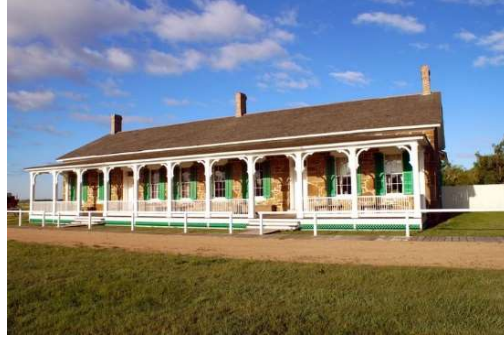
KHRI #: 145-122 [Pawnee Co.]
 Historic name: Ft Larned: Quatermaster Store
 Date of construction: 1867
 Architectural integrity: Moderate changes
 Architectural integrity notes: Renovated/orig;
 after military use; was converted to barn
 Association w/trail: *DIR* located on the SFT
 WGS-84: 38.182440 -99.217910
 NR listed: 10/15/1966 [NHL: 1960]

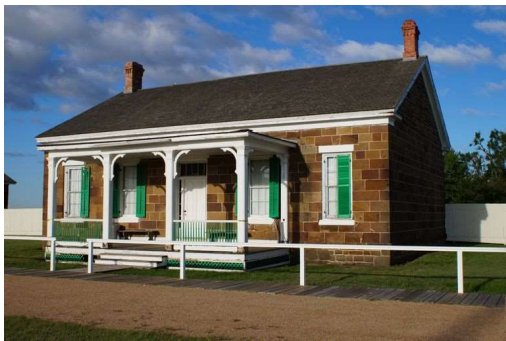
KHRI #: 145-123 (Pawnee Co.)
 Historic name: Fort Larned: Officers' Quarters
 Date of construction: 1867
 Architectural integrity: Minor changes
 Architectural integrity notes: After early 1870s; served
 as Post Surgeon's Quarters
 Association w/trail: *DIR* located on the SFT
 WGS-84: 38.182470 -99.218800
 NR listed: 10/15/1966 [NHL: 1960]

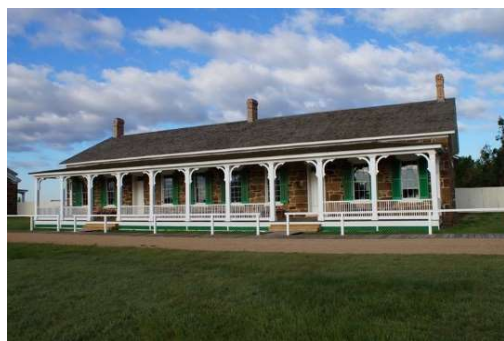
KHRI #: 145-124 [Pawnee Co.]
 Historic name: Fort Larned: Com. Off Quarters
 Date of construction: 1867
 Architectural integrity: Minor changes
 Architectural integrity notes: Needs maint.
 work on exterior trim and porches
 Association w/trail: *DIR* located on the SFT
 WGS-84: 38.182810 -99.218980
 NR listed: 10/15/1966 [NHL: 1960]

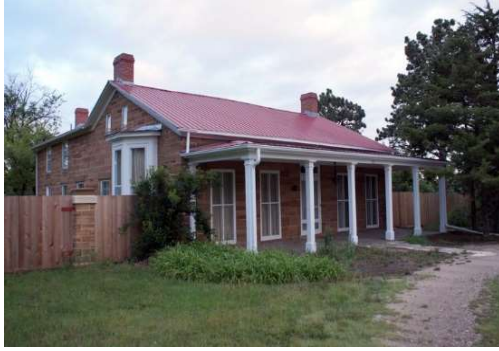
KHRI #: 145-125 [Pawnee Co.]
 Historic name: Fort Larned: Officers' Quarters
 Date of construction: 1867
 Architectural integrity: Minor changes
 Architectural integrity notes: Currently displayed to
 resemble five separate living quarters
 Association w/trail: *DIR* located on the SFT
 WGS-84: 38.183150 -99.219180
 NR listed: 10/15/1966 [NHL: 1960]

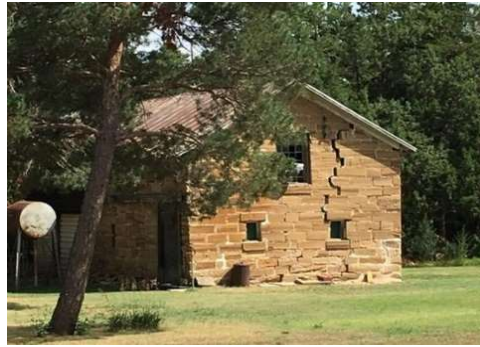
KHRI #: 145-136 [Pawnee Co.]
 Historic name: Hillcrest Barn
 Date of construction: 1878
 Architectural integrity: Moderate changes
 Architectural integrity notes: E end of barn converted to garage; has weakened overall building. Note crack.
 Association w/trail: *IND* .71 miles NW of SFT
 WGS-84: 38.178420 -99.115040
 SR/NR eligibility: Not assessed

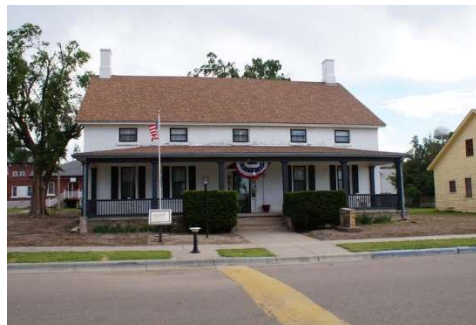
KHRI #: 057-1821-00002 [Ford Co.]
 Historic name: Fort Dodge: Commanding Off. Quarters
 Date of construction: 1867
 Architectural integrity: Minor changes
 Architectural integrity notes: Front, south elevation is painted; north elevation stuccoed; has garage add.
 Association w/trail: *DIR* .07 miles S of SFT
 WGS-84: 37.732120 -99.936050
 SR/NR eligibility: Not assessed

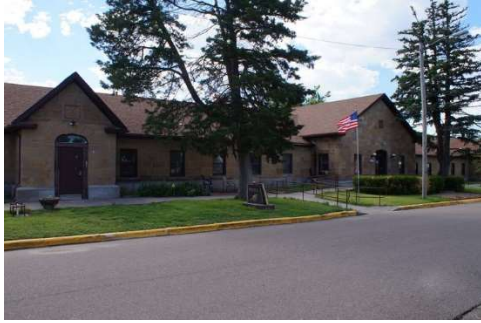
KHRI #: 057-1821-00003 [Ford Co.]
 Historic name: Fort Dodge: Enlisted Barracks
 Date of construction: 1867
 Architectural integrity: Major changes
 Architectural integrity notes: Adobe barracks removed 1930s; two barracks combined
 Association w/trail: *DIR* .12 miles S of SFT
 WGS-84: 37.731090 -99.935600
 SR/NR eligibility: Not assessed

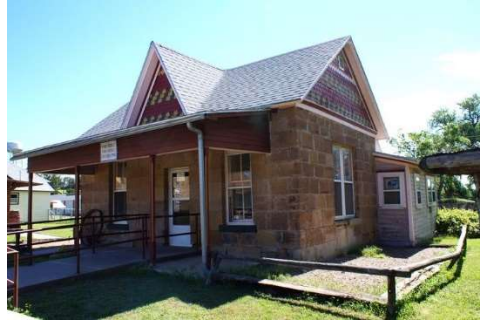
KHRI #: 057-1821-00005 [Ford Co.]
 Historic name: Fort Dodge: Officers House
 Date of construction: 1867
 Architectural integrity: Moderate changes
 Architectural integrity notes: Ext. needs major work; interior renovated as function needs dictated.
 Association w/trail: *DIR* .08 miles S of SFT
 WGS-84: 37.731650 -99.935460
 SR/NR eligibility: Not assessed

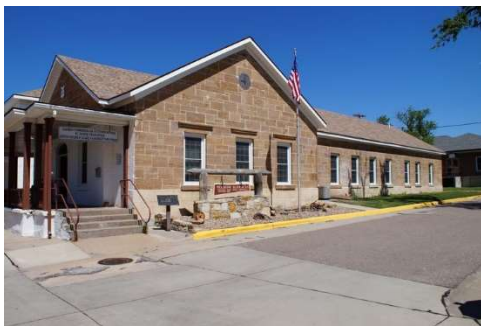
KHRI #: 057-1821-00004 [Ford Co.]
 Historic name: Fort Dodge: Old Hospital
 Date of construction: 1867
 Architectural integrity: Major changes
 Architectural integrity notes: Several exterior additions; interior offices
 Association w/trail: *DIR* .09 miles S of SFT
 WGS-84: 37.732260 -99.937060
 SR/NR eligibility: Not assessed

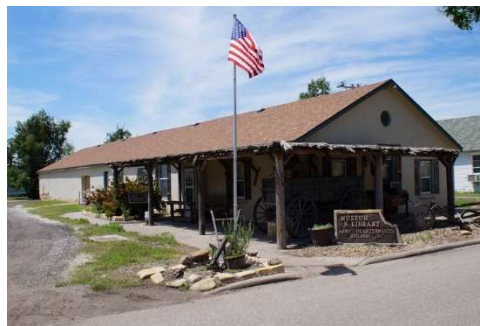
KHRI #: 057-1399 [Ford Co.]
 Historic name: Fort Dodge: Army Quartermaster Bldg.
 Date of construction: 1867
 Architectural integrity: Moderate changes
 Architectural integrity notes: building covered w/stucco; stucco damaging stone surface; interior renovated
 Association w/trail: *DIR* .16 miles S of the SFT
 WGS-84: 37.731330 -99.937530
 SR/NR eligibility: Not assessed

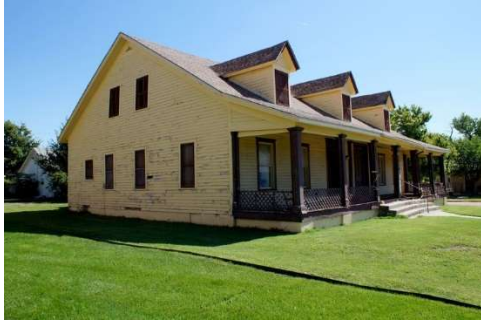
KHRI #: 057-1426 [Ford Co.]
 Historic name: Fort Dodge: Jr Off Quarters
 Date of construction: 1870
 Architectural integrity: Minor ext. changes
 Architectural integrity notes: Slated for demolition although repairable
 Association w/trail: *DIR* .07 miles S of SFT
 WGS-84: 37.732070 -99.935730
 SR/NR eligibility: Not assessed

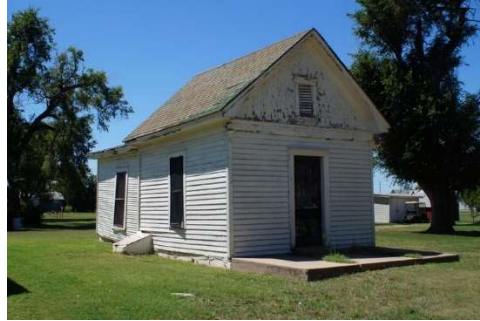
KHRI #: 057-1427 [Ford Co.]
 Historic name: Fort Dodge: Dead House [Relocated]
 Date of construction: 1870
 Architectural integrity: Rear elevation shed addition
 Architectural integrity notes: rear wall removed creating a single room; interior features were removed
 Association w/trail: *DIR* original loc./.05 miles S of SFT
 WGS-84: 37.731370 -99.937900
 SR/NR eligibility: Not assessed
