Preliminary Site Information Questionnaire (PSIQ)

1. **Historical Name of Property:** Fort Dodge
2. **Current Name or Other Names of the Property:** Fort Dodge: Kansas Soldiers' Home
3. **Street Address or Location (or Section/Township/Range):** Fort Dodge is located approximately 5 miles east of Dodge City, Kansas, on Highway 400 at 714 Sheridan, Fort Dodge, Kansas 67843
4. **City (or Vicinity):** Dodge City, Kansas **County:** Ford
5. **Historical Use:** Fort Dodge was a United States Army Post that protected those traveling the Santa Fe Trail and provided supplies and a resting place for traders and bison hunters. **Present Use:** The Kansas Soldiers Home is a State-operated facility on the grounds of Old Fort Dodge, an active military post from 1865-1882. The Fort was deeded to the State of Kansas in 1889 for conversion into a Soldiers' Home.

Site One: Fort Dodge Junior Officers Quarters (Condition Assessment)	Page 4 - 10
Site Two: Fort Dodge – Officers House (Condition Assessment)	Page 11 - 15
Site Three: Fort Dodge – Army Quartermaster Building (Condition Assessment)	Page 16 - 22
Site Four: Fort Dodge – Enlisted Men’s Barracks (Condition Assessment)	Page 23 - 29
Site Five:

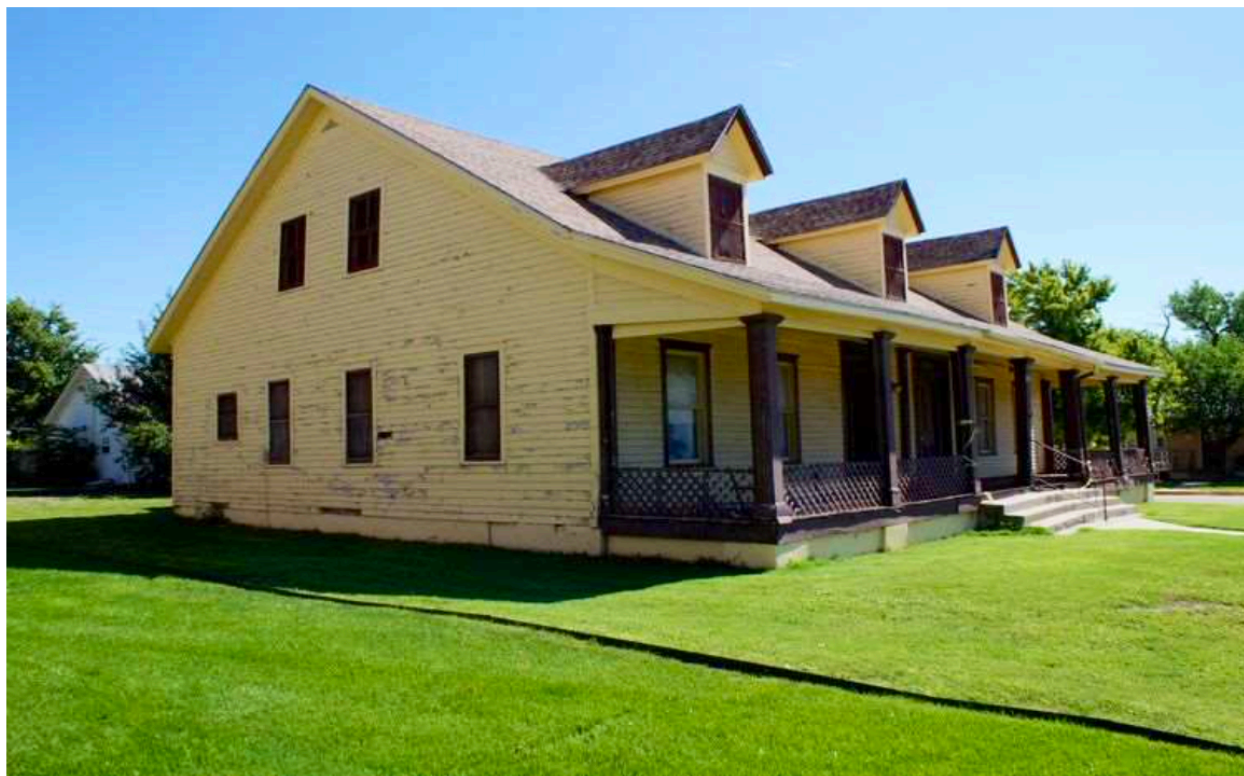
S1-001: Fort Dodge Junior Officers' Quarters ca. 1870 (KHRI: 057-1426). West and south (front) elevations; looking northeast.

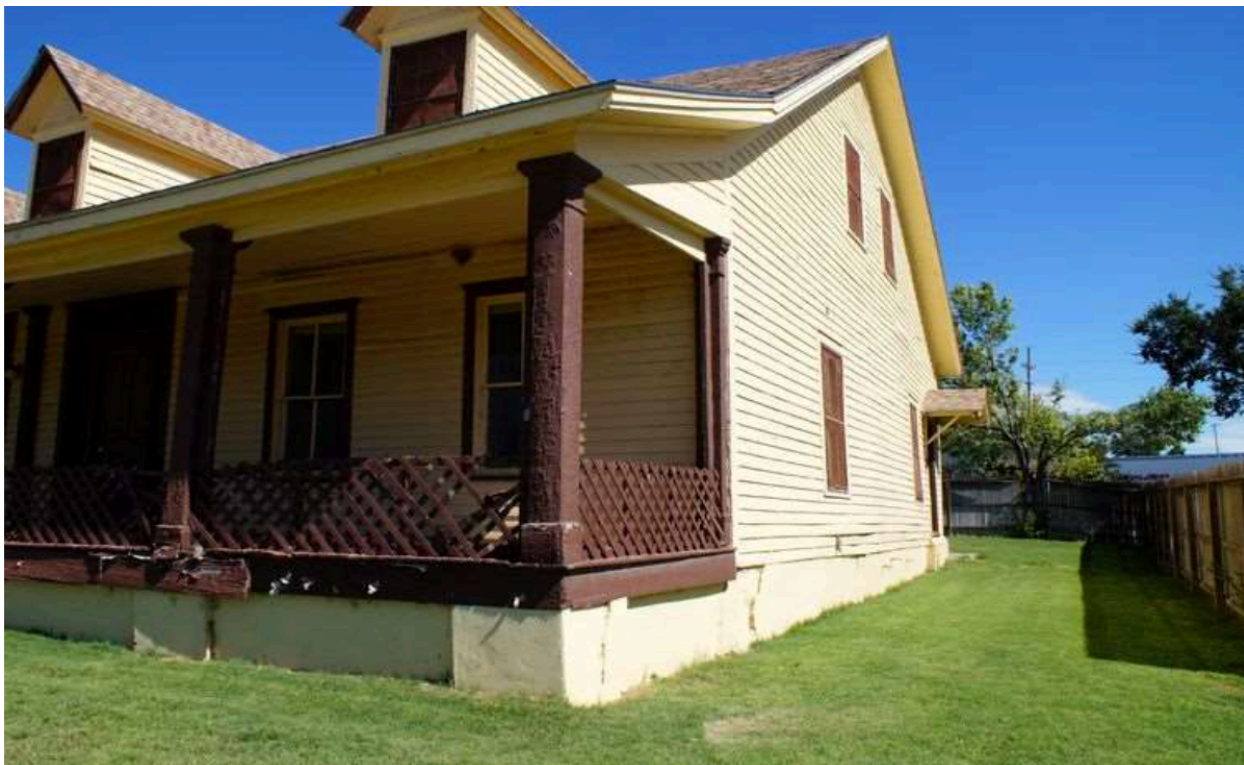
S1-002: Fort Dodge Junior Officers' Quarters ca. 1870 (KHRI: 057-1426). South (front) and east elevations; looking north-northwest.

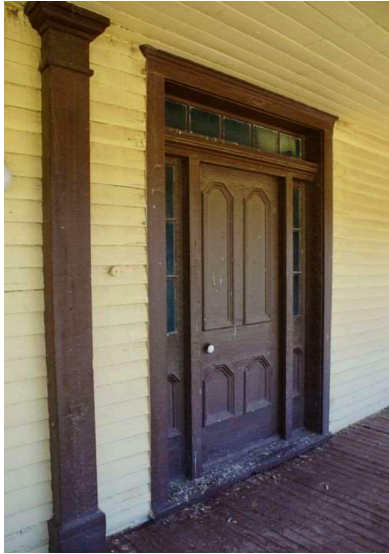
S1-003: Fort Dodge Junior Officers' Quarters ca. 1870 (KHRI: 057-1426). South (front) elevation, primary entrance to the east side of Junior Officers' Quarters; looking northeast.

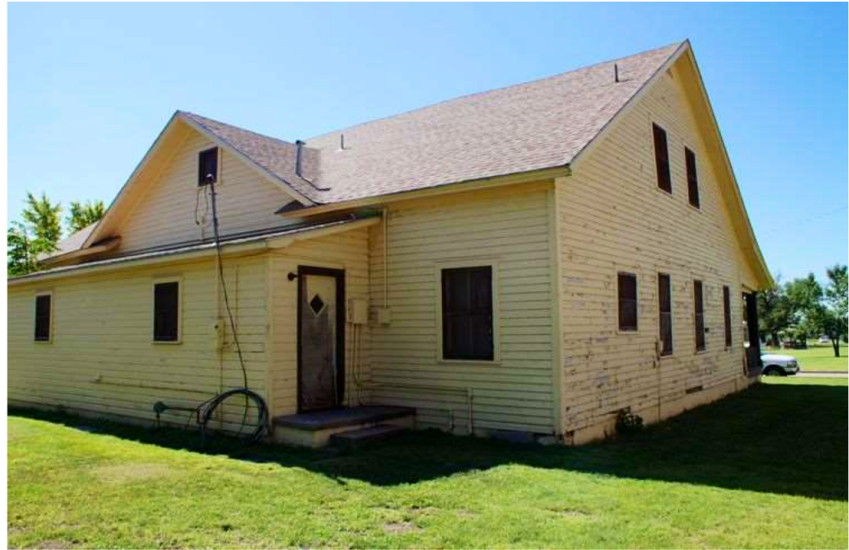
S1-004: Fort Dodge Junior Officers' Quarters ca. 1870 (KHRI: 057-1426). North and west elevations: looking south-southeast.

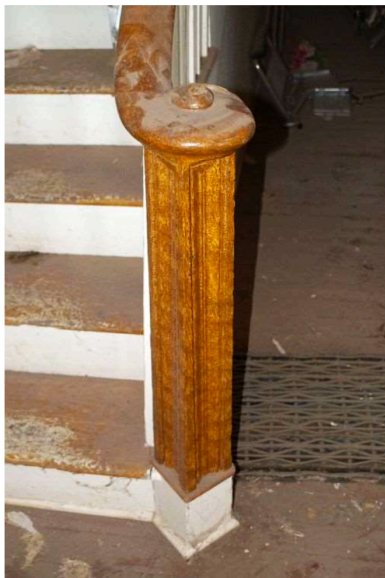
S1-005: Fort Dodge Junior Officers' Quarters ca. 1870 (KHRI 057:-1426). First-floor, east side of Junior Officers Quarters; details of the lower newel post and hand rail; looking north

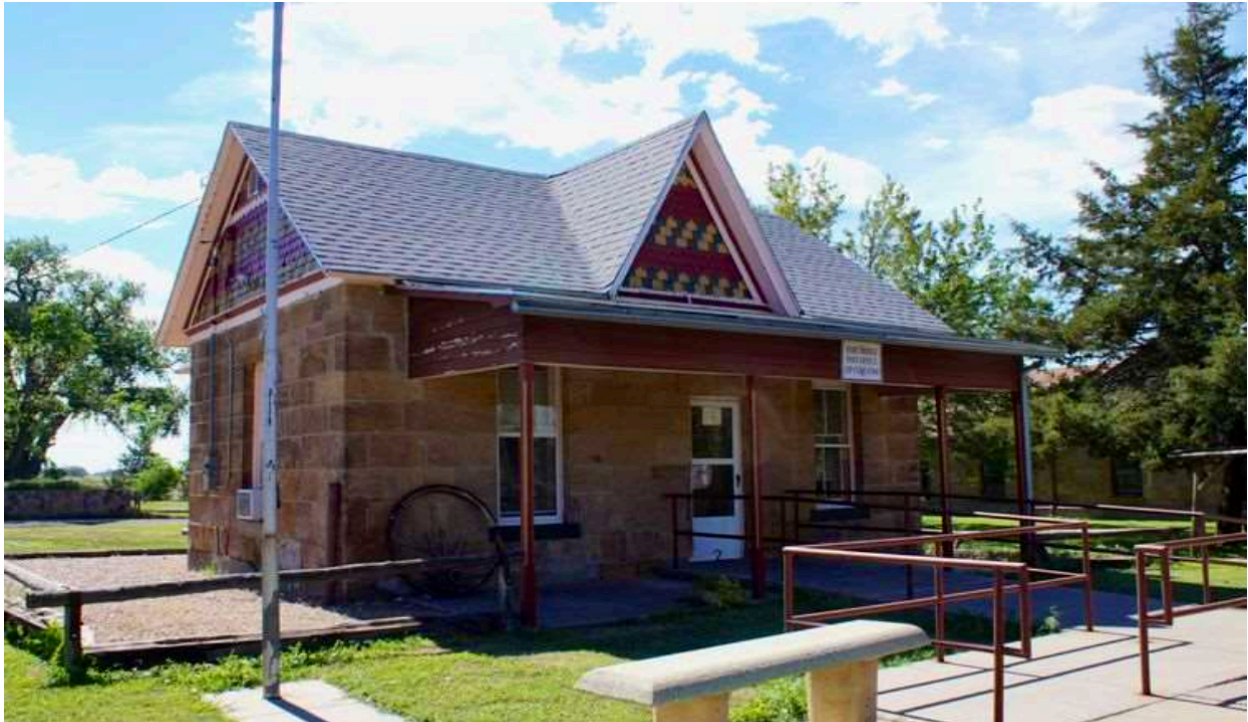
S2-001:Fort Dodge Officers House ca. 1867 (KHRI: 057-1821-00005). West elevation; looking east.

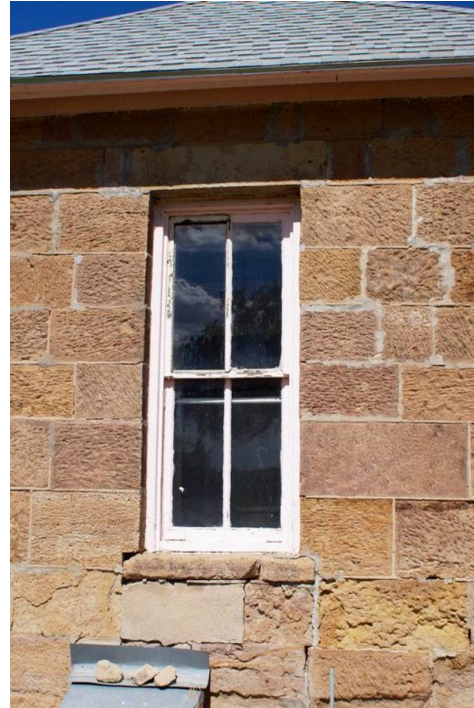
S2-004: Fort Dodge – Officers House. East elevation, typical 2/2, double-hung windows; looking west. 05/25/2017. KSHS/Anderson, Rick.

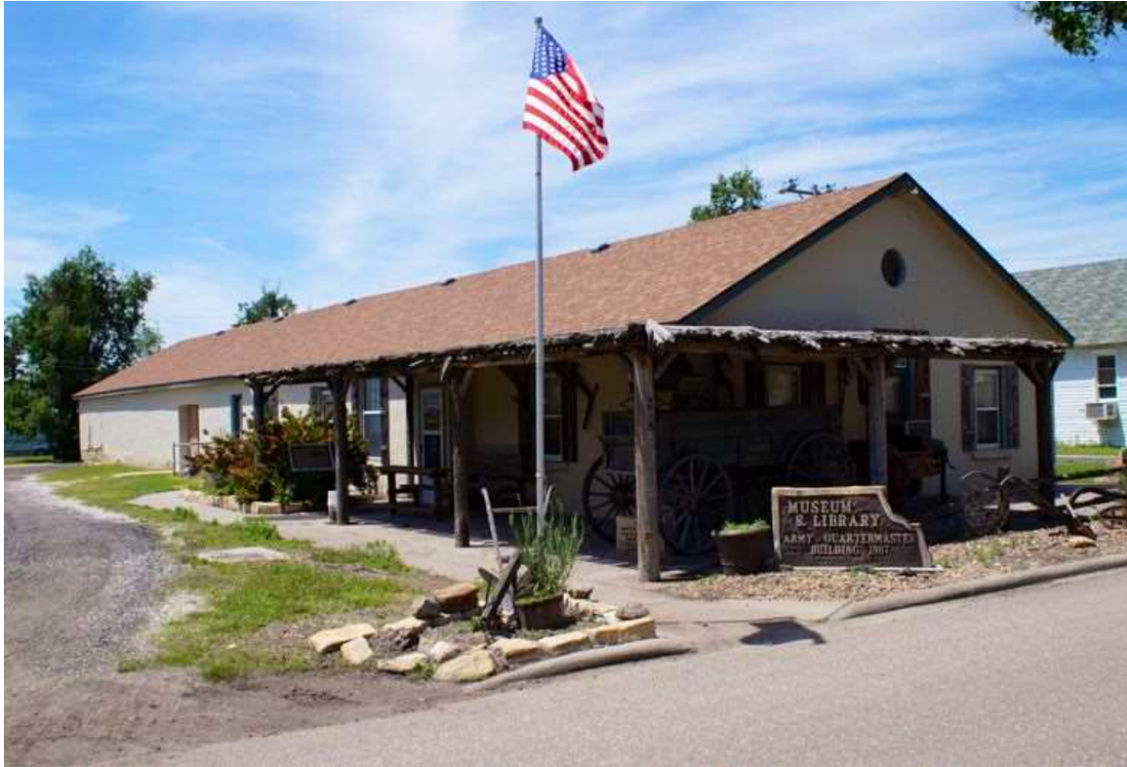
S3-001: Fort Dodge Army Quartermaster Building ca. 1867 (KHRI: 057-1399). East (front) and north elevation; looking southwest.

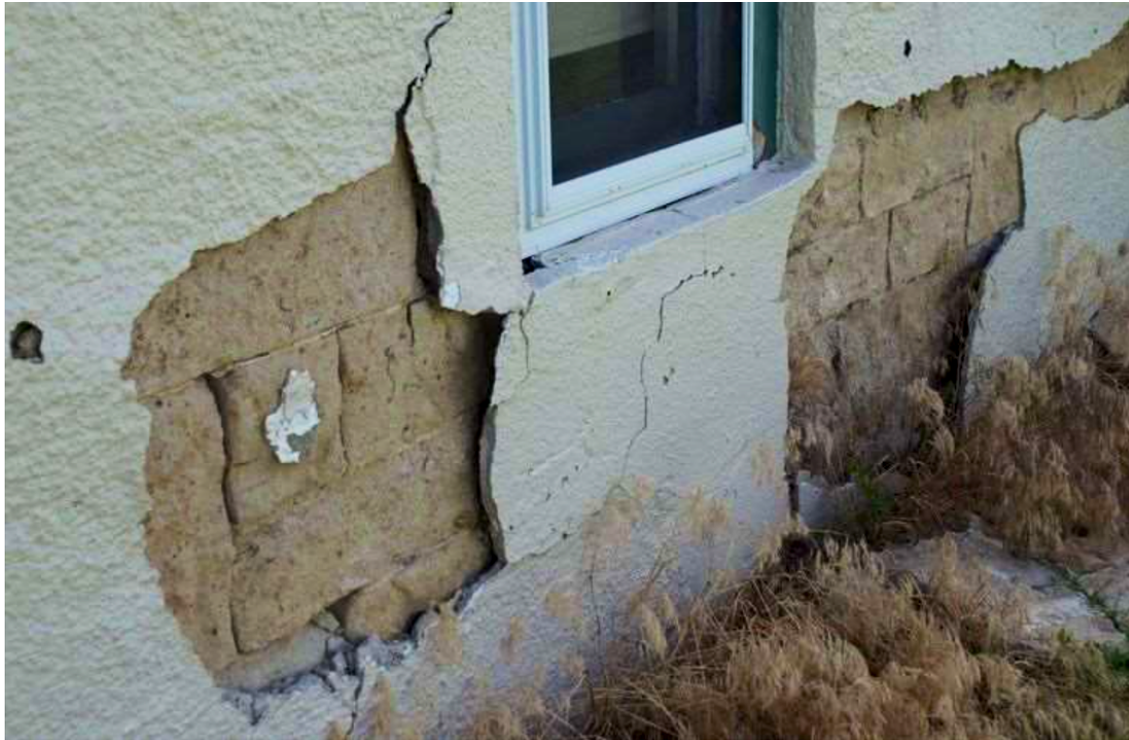
S3-003: Fort Dodge Army Quartermaster Building ca. 1867 (KHRI: 057-1399). West elevation; looking southeast.

Other damage notes: To summarize the damage would be best to address the application of stucco to the whole of the building. The stucco covering is separating and falling off in large patches on the west, south, and east elevations. The west and south elevations have sustained the most damage from the stucco. The faces of the limestone blocks on the affected elevations have suffered considerable spalling from the stucco removing itself. The lower level of the west elevation has an application of concrete (similar to the Enlisted Men’s Barracks building; KHRI 057-1821-00003) that is visible where the stucco has flaked off. Closer inspection of the damage shows the same concern in that the limestone blocks are spalling and cracking just above the concrete application.

Intervention level: Noted items should be kept under close observation. Develop a plan to slow down or eliminate further deterioration of the exterior.

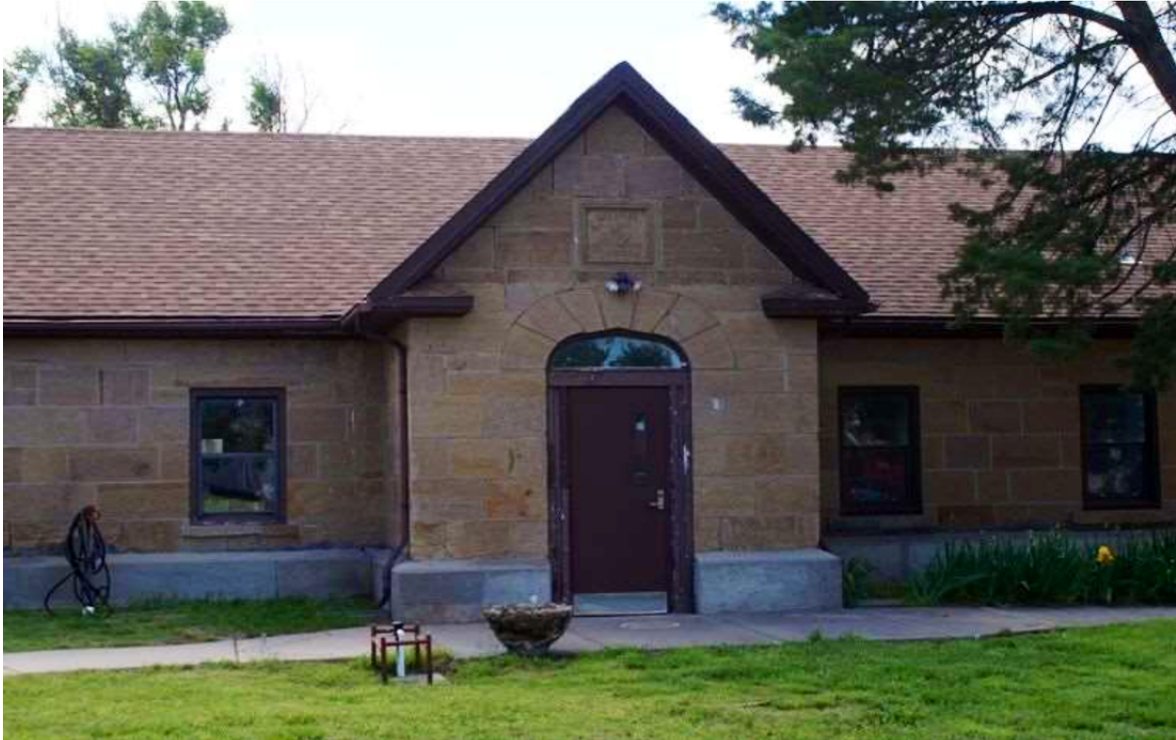
S4-001: Fort Dodge Enlisted Men's Barracks ca. 1867 (KHRI: 057-1821-00003). West (front) elevation of south barracks; looking northeast.

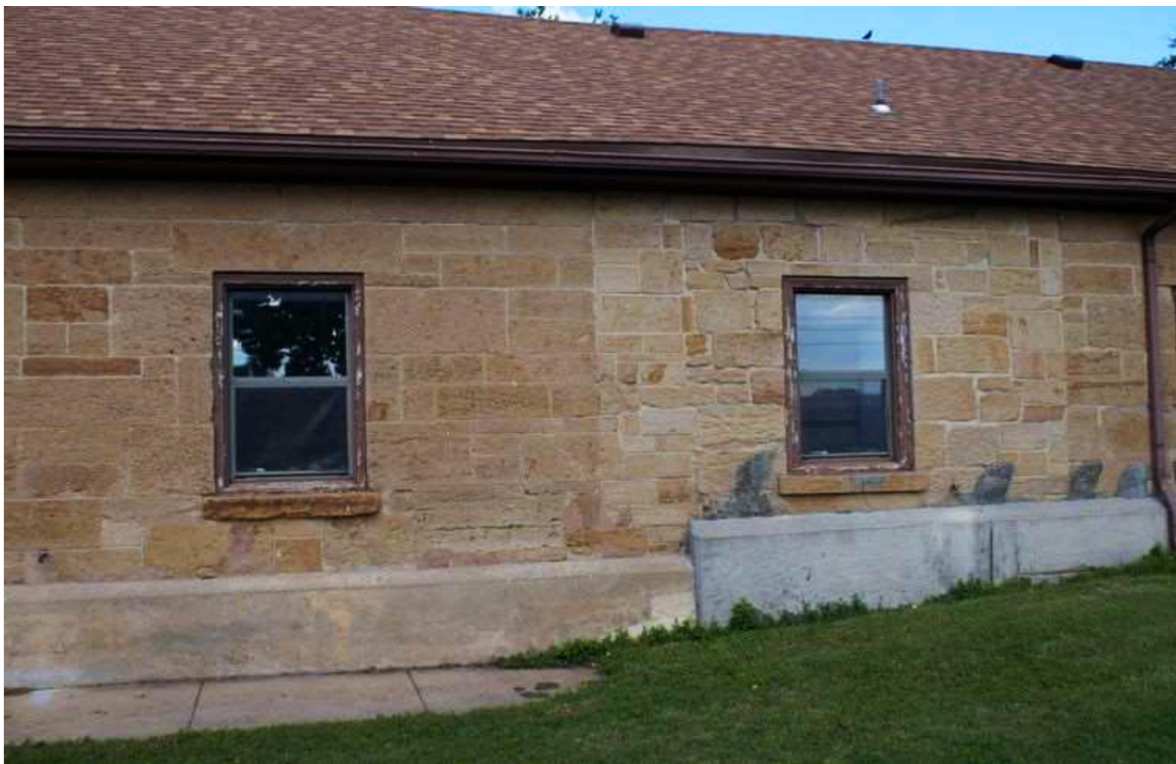
Foundation damage: Severe; concrete has been inappropriately poured on at least two different occasions coming in direct contact with the foundation and the lower wall surfaces of all elevations. See “Other notes” below.

S4- 002: Fort Dodge Enlisted Men's Barracks ca. 1867 (KHRI: 057-1821-00003). South end of south barracks at the west (front) and south elevations; looking northeast. Note application of concrete/gunite at base of walls that encompasses the entire building; shown here in green.

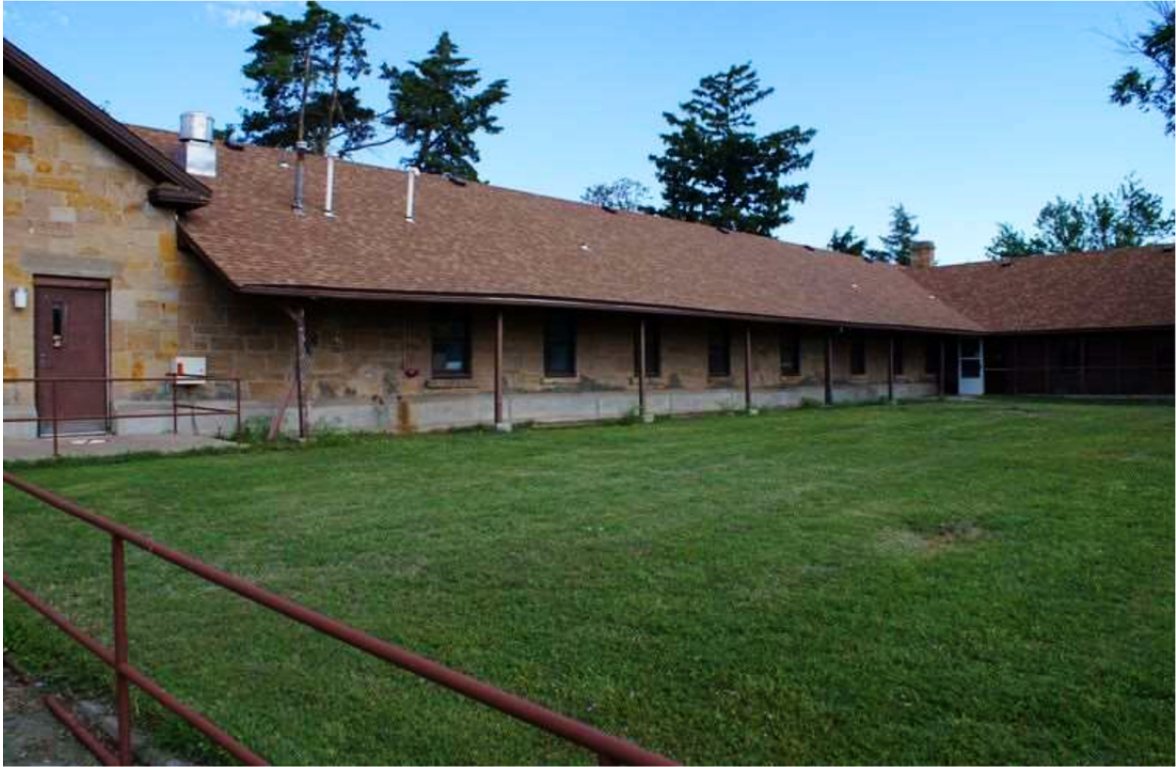
S4-003: Fort Dodge Enlisted Men's Barracks ca. 1867 (KHRI: 057-1821-00003). East elevation of north barracks; looking northwest.

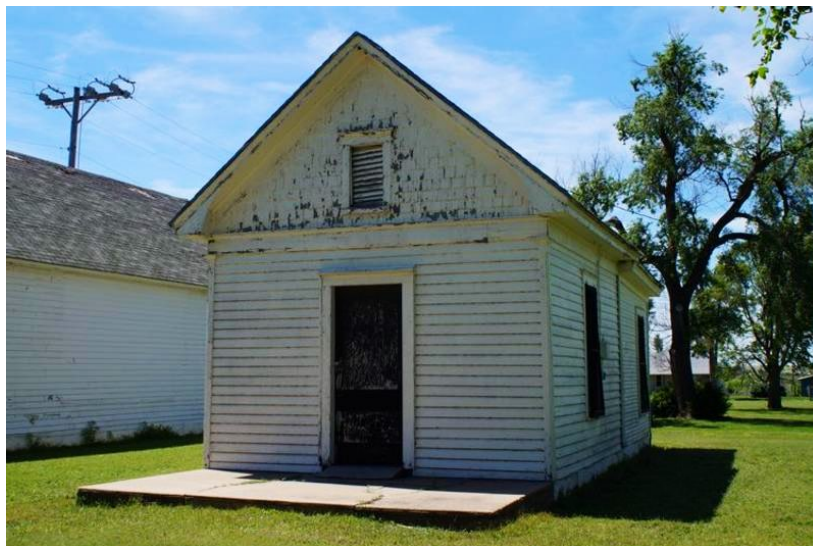
S5-001:Fort Dodge – Dead House (Relocated). 317 Pershing Street. North (front) and west elevation; looking south-southwest. 05/25/2017. KSHS/Anderson, Rick.

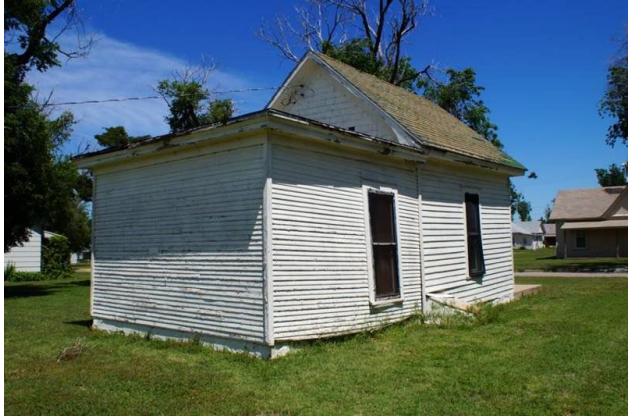
S5-002: Fort Dodge – Dead House (Relocated). 317 Pershing Street. South and east elevations of the shed addition; looking northwest. East elevation of the original building and its south gable shown above the shed addition. 05/25/2017. KSHS/Anderson, Rick.

Intervention level: Items noted need to be kept under observation. The multiple layers of shingles on the original building should be removed and then re-roofed. The shed addition should be shored back up to the correct height or remove the addition and repair the original building's south wall for period correctness and to save the building from further deterioration. (See "Leaning, other structural damage" above.)

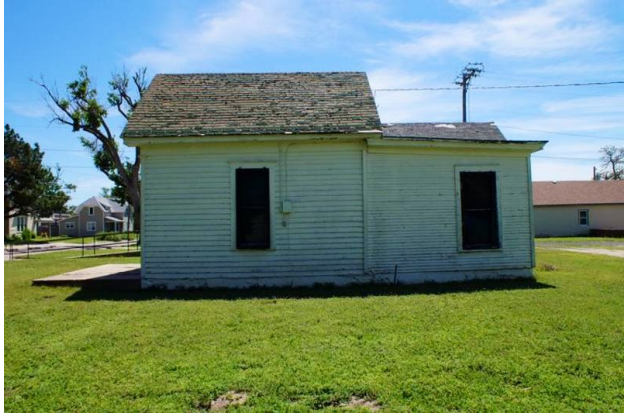
S5-003: Fort Dodge – Dead House (Relocated). 317 Pershing Street. West elevation of the original building (left) and shed addition (right); looking north-northeast. 05/25/2017. KSHS/Anderson, Rick.

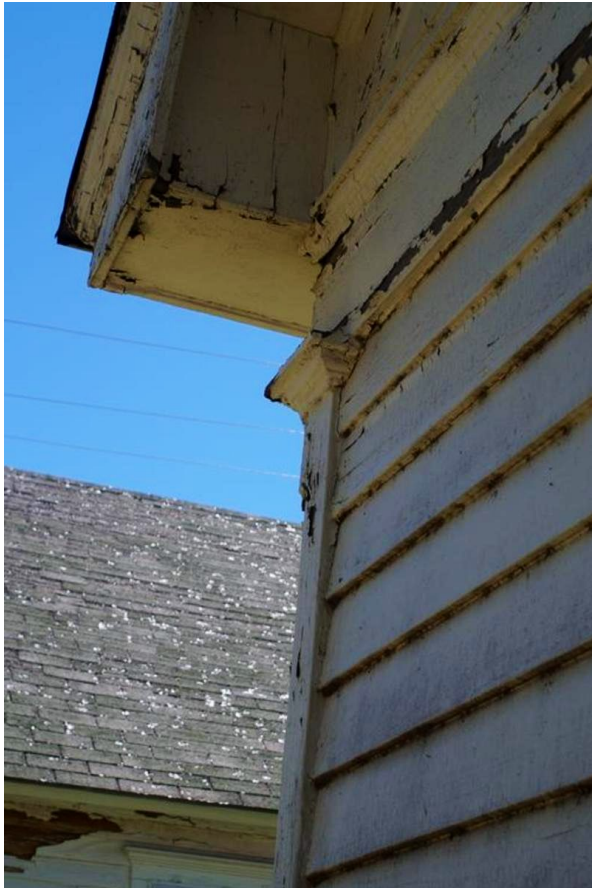
S5-004: Fort Dodge – Dead House (Relocated). 317 Pershing Street. North elevation details of corner trim boards, eave, soffit and fascia; looking east. 08/16/2017. KSHS/Anderson, Rick.

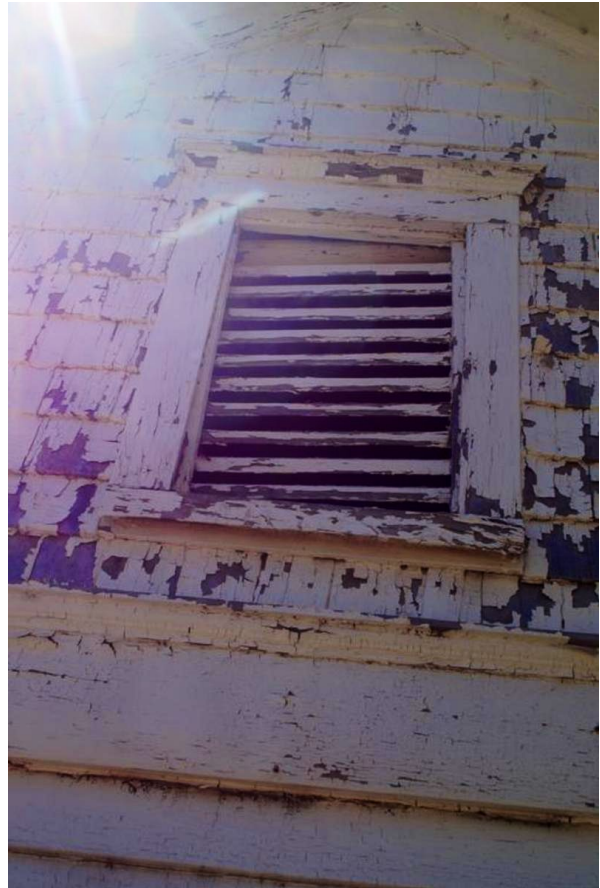
S5-005: Fort Dodge – Dead House (Relocated). 317 Pershing Street. North elevation louver; looking south. 08/16/2017. KSHS/Anderson, Rick.

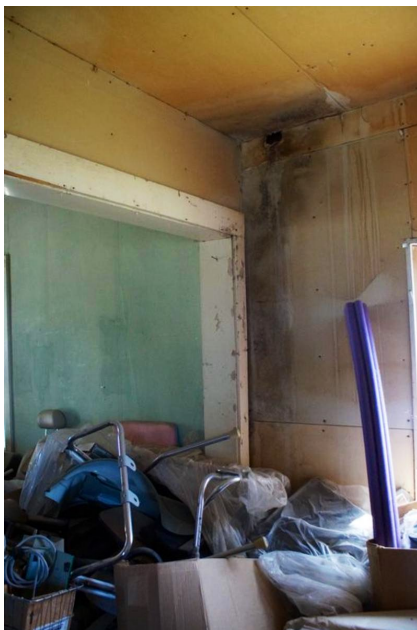
S5-007: Fort Dodge – Dead House Interior, northeast corner of the shed addition where it adjoins the original building; looking northeast. 08/16/2017. KSHS/Anderson, Rick.
